Walker Home Inspection

Property Inspection Report

Your Home , Hometown, VA
Inspection prepared for: Sample Report
Date of Inspection: 9/6/2022 Time: 9:45-12:30 pm Size: 5000 sqft
Weather: Recent rain

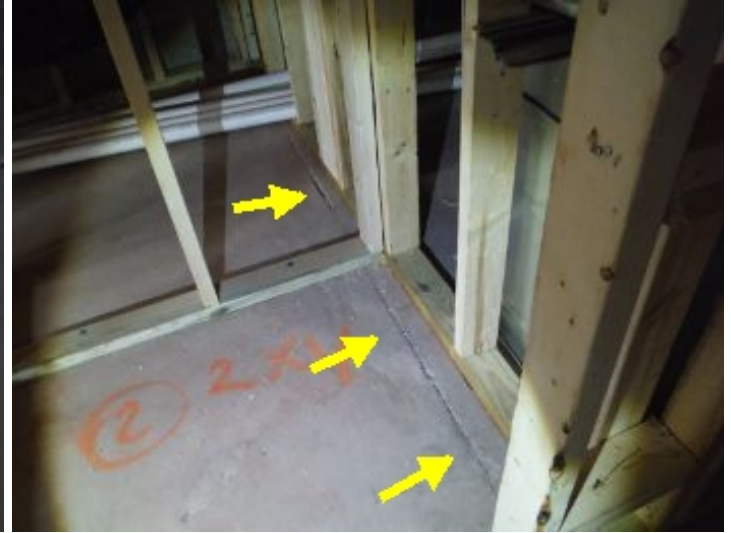
- Crack visible. Repair and monitor. Cracks 1/4" or less are generally not regarded as being structurally significant. Recommend patching area and sealing to prevent possible entry points for moisture, radon gases and to prevent further damage.

Crack visible

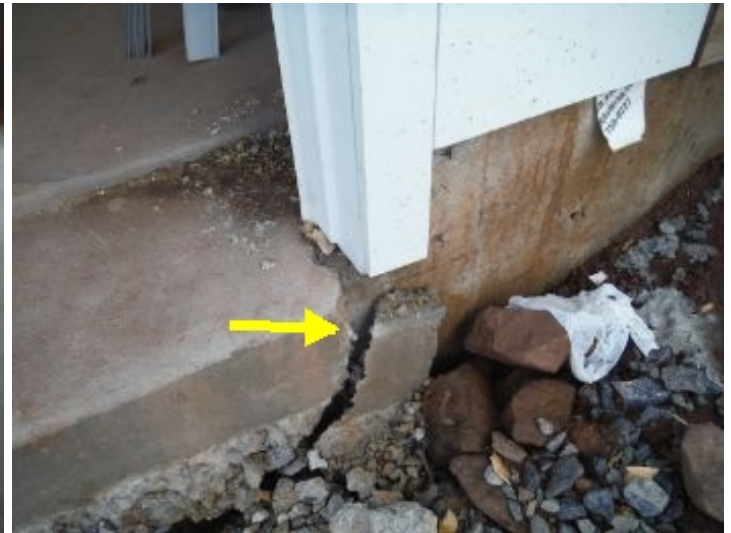
Recommend sealant

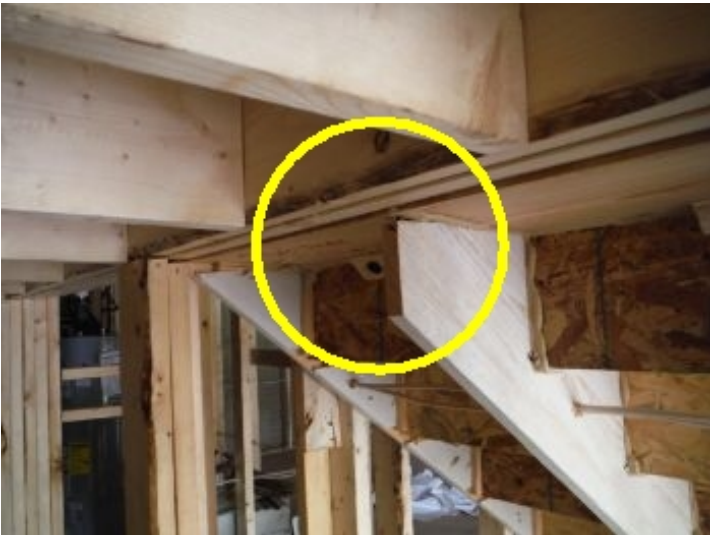
- Hole(s) in floor sheathing. Unsure of purpose. If not needed repair to prevent possible spreading of smoke and/or fire.
- Stair stringer over notched. Over notching weakens the stringer's overall strength by reducing the effective depth of the stringer member. The resulting throat of the stringer should not be less than the prescribed throat, which, for a 2x12, is approximately 5 inches.
- Missing bearing: Stair stringer missing bearing on header or connector. Recommend minimum of 1 1/2 inch bearing per stringer or added connector.
- Fireblock not visible. Prevent drafts, pests, fire, or smoke spread. Ensure all floor penetrations and openings are sealed with fireblock spray foam or caulk.

Fireblock not visible

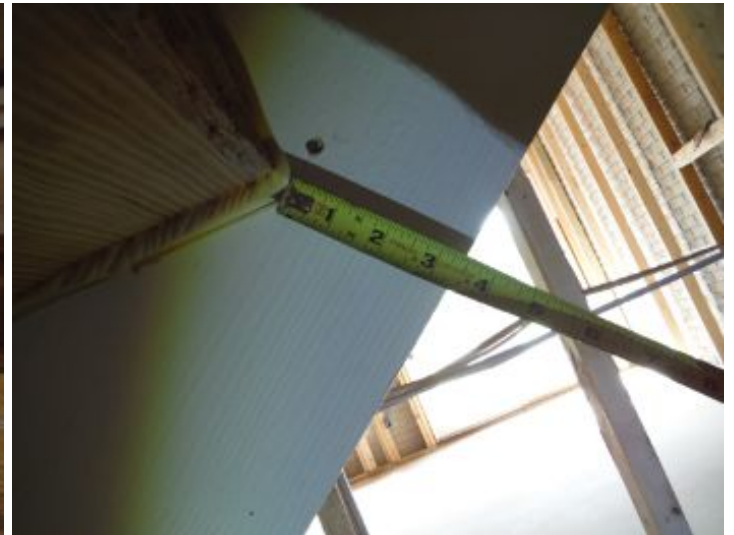
Missing bearing or hanger

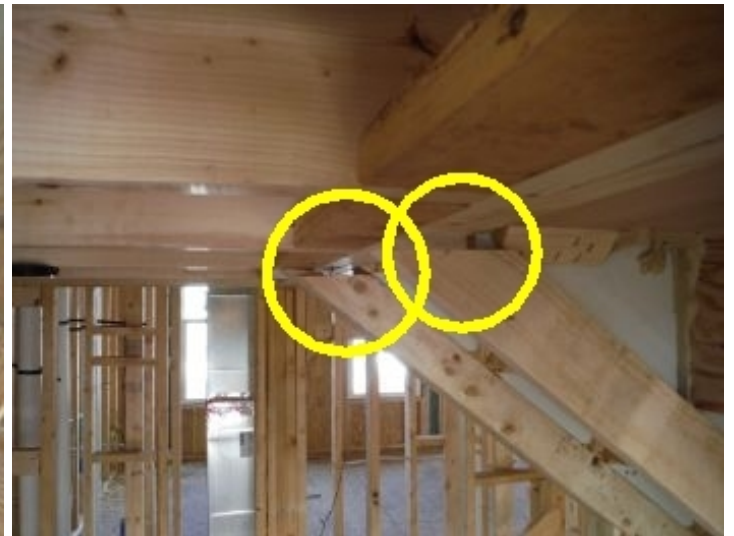
Fireblock not visible

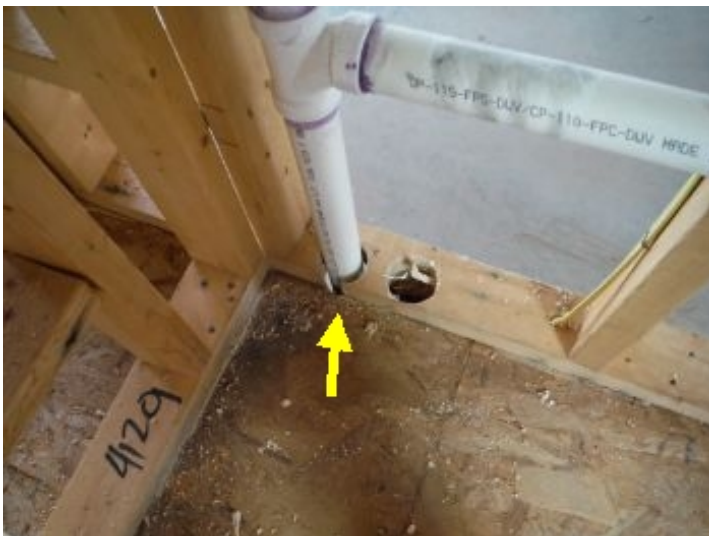
- Nail plates missing. A nail plate keeps users from hammering nails into the area in wood framing where utilities run through, thus protecting cables, wires or tubing from costly accidents. Prevent damage to plumbing and electrical components. Recommend installation of nail plates where electrical or plumbing passes through a framing member and is less than 1 1/4" from the surface of the stud.

Missing nail plate

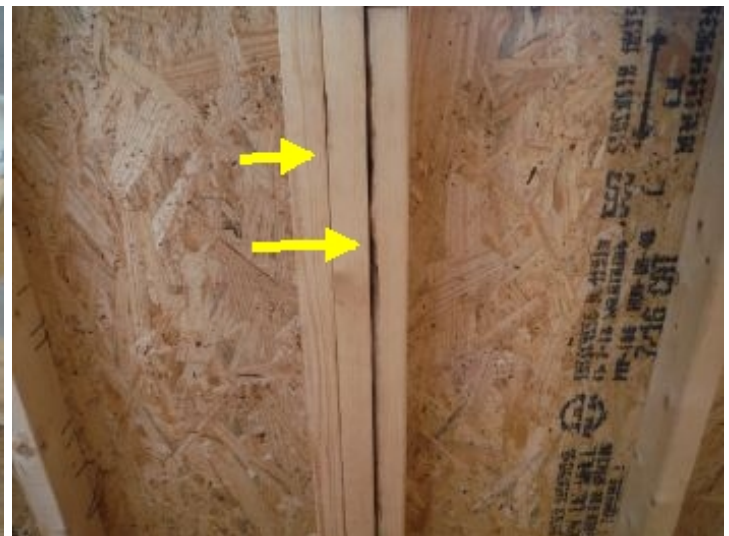
Missing sealant Laundry

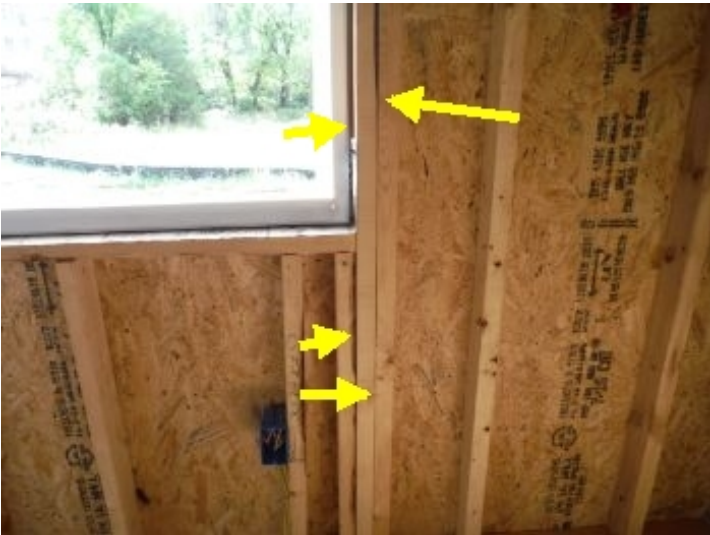
Missing sealant Laundry

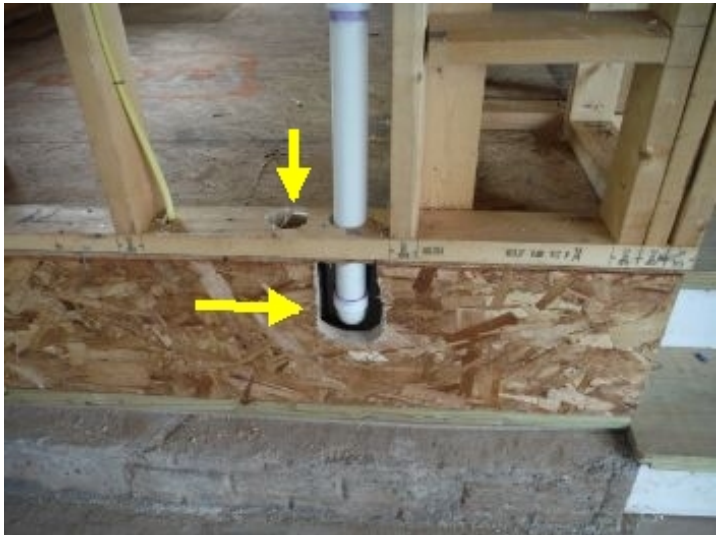
Hole in sheathing/ missing fireblock

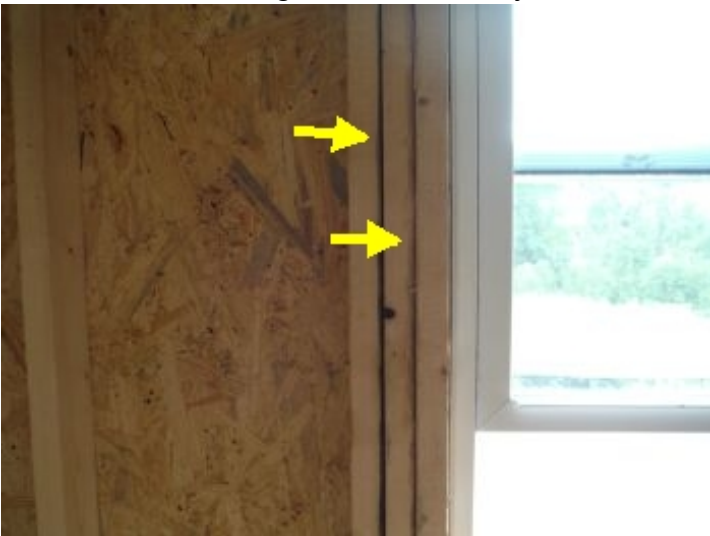
Missing sealant

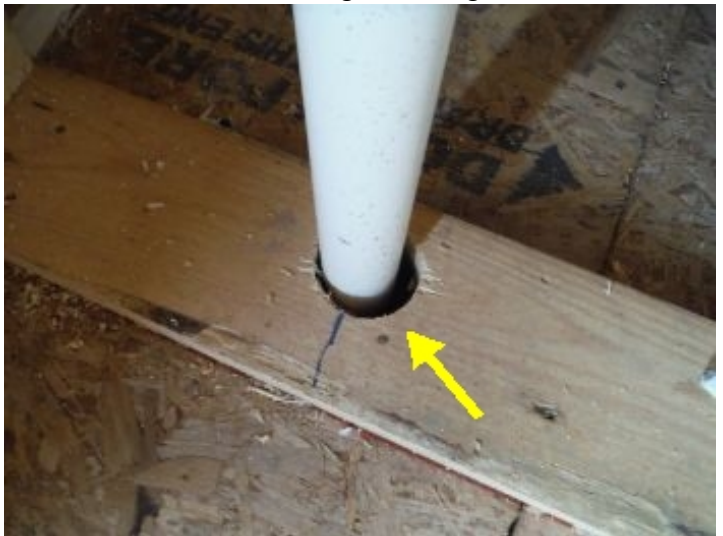
Missing fireblock

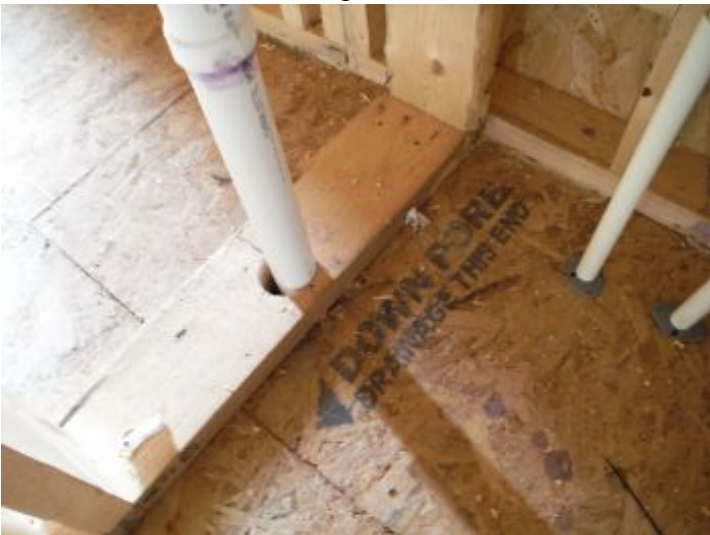
Missing nail plate

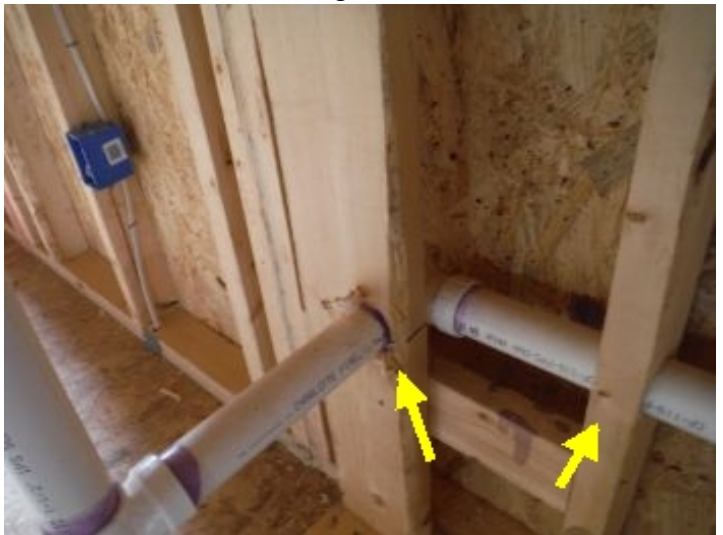
Missing nail plate Main lvl bath

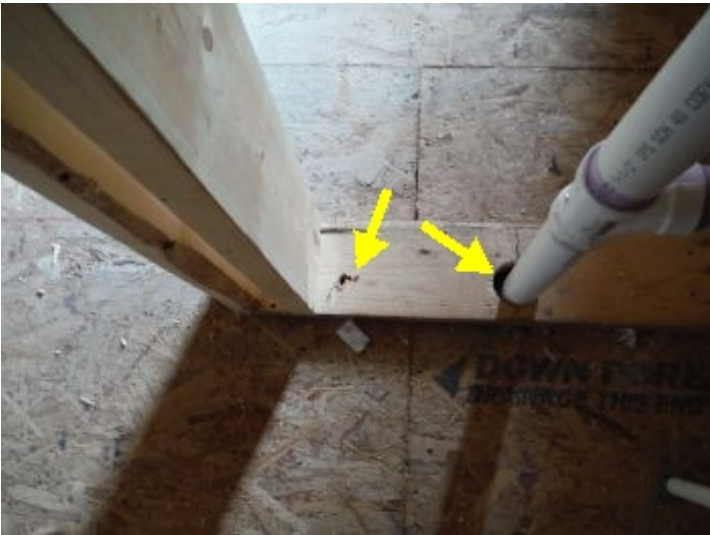
Missing fireblock Main lvl bath

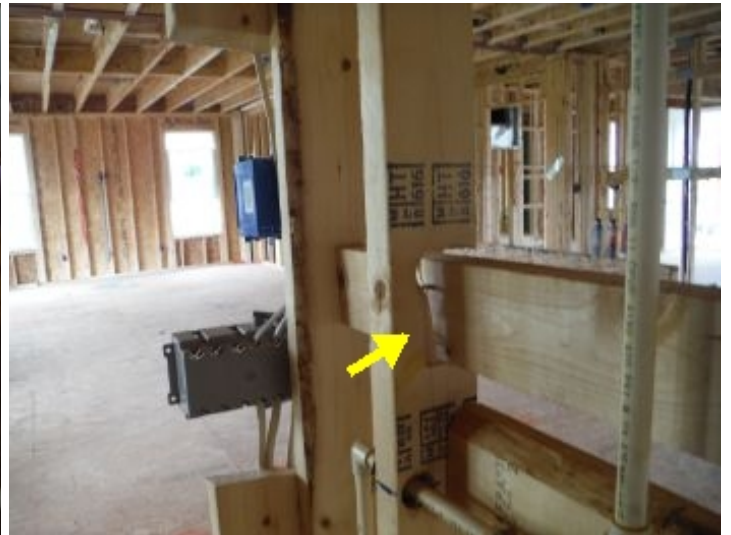
- Stud notch large. The remaining section is small and weak. Notches should not be larger than 40% of the stud width. Stud shoe, metal strap, or additional framing should be used for additional support.

Stud notch large

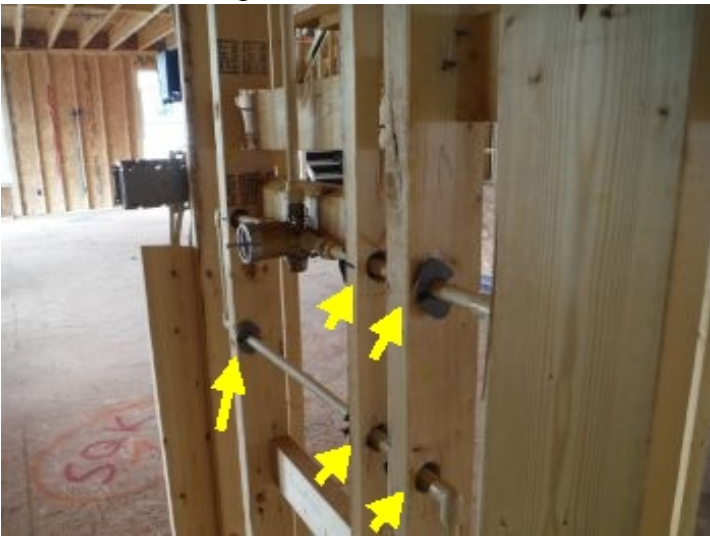
Missing nail plate

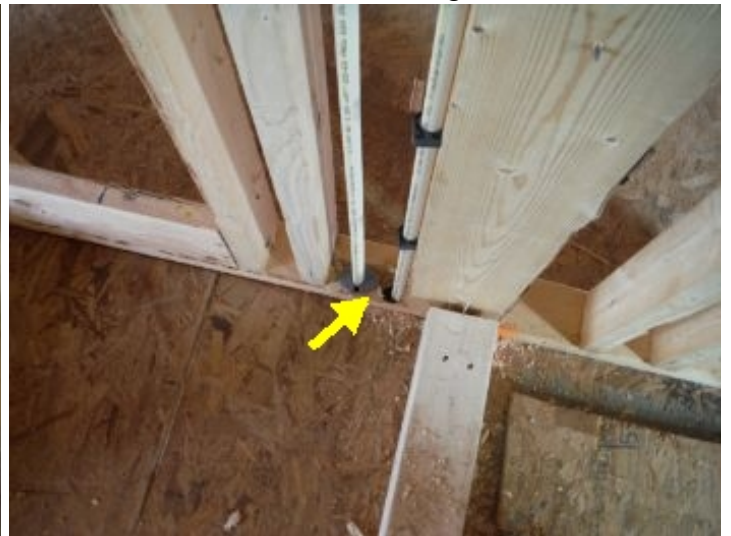
Missing fireblock

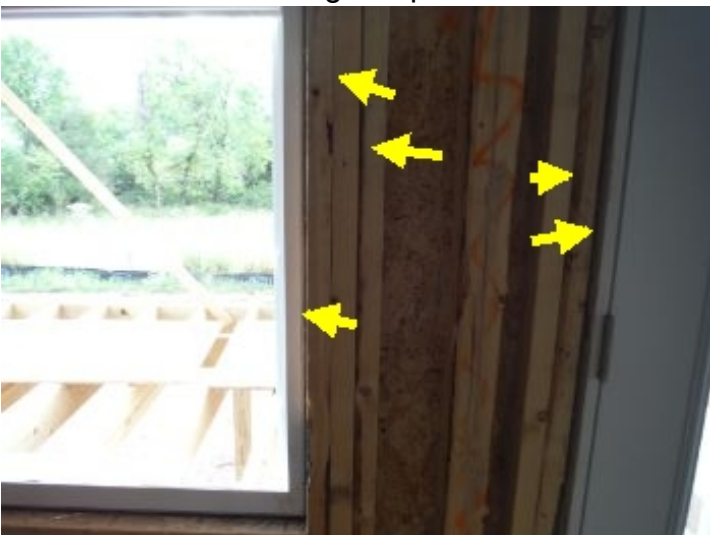
Missing sealant Living area

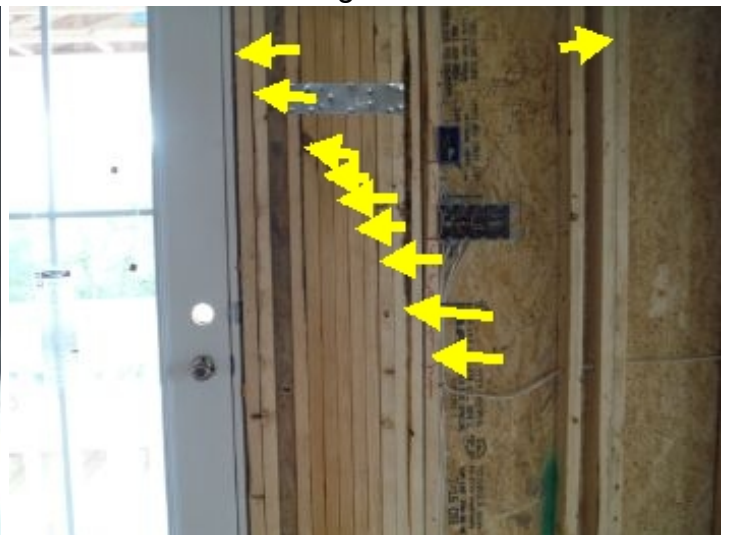
Missing sealant

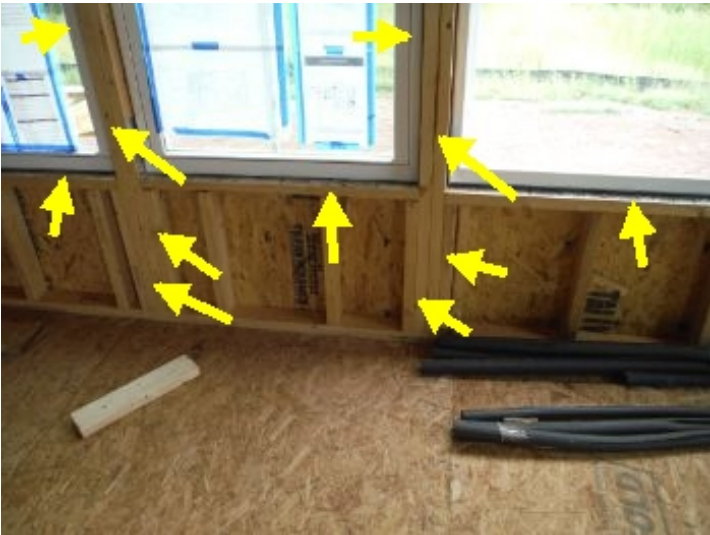
Missing sealant

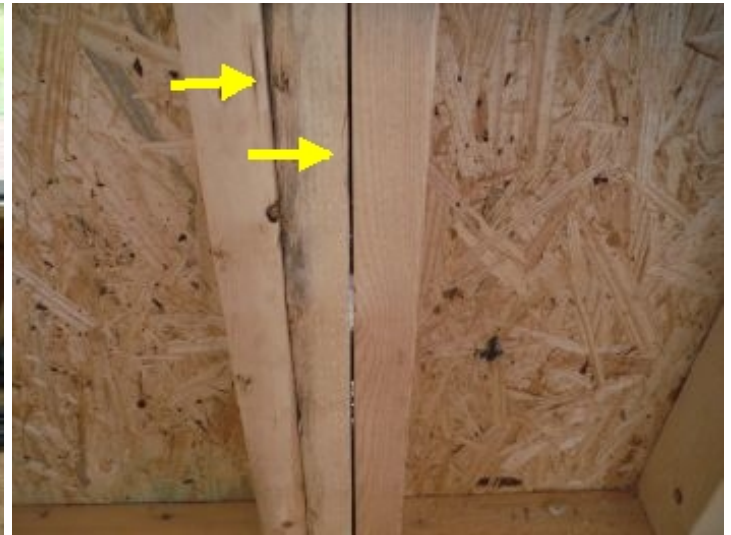
Missing sealant Study

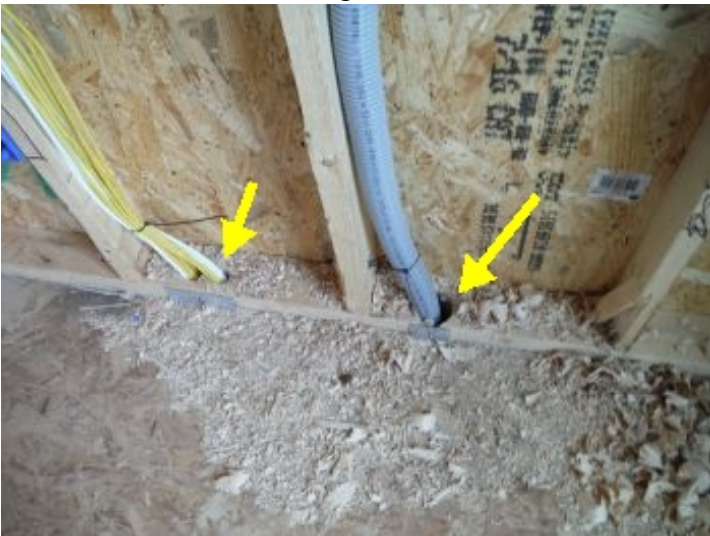
Missing fireblock Study

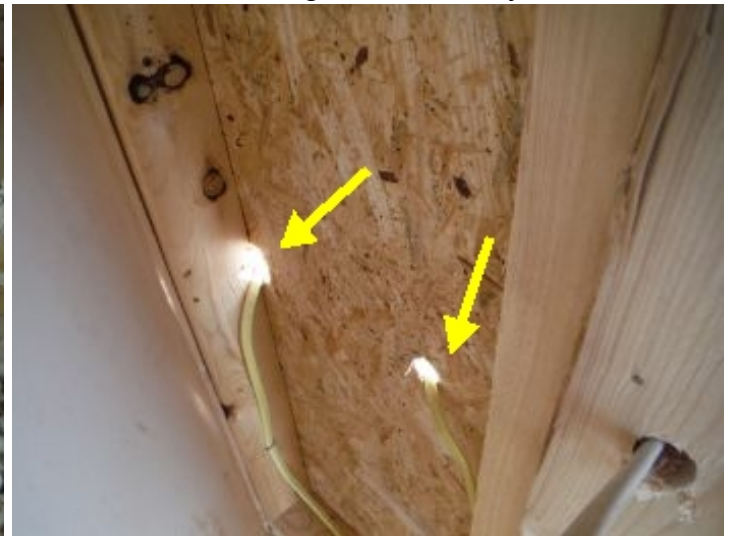
Sheathing penetration

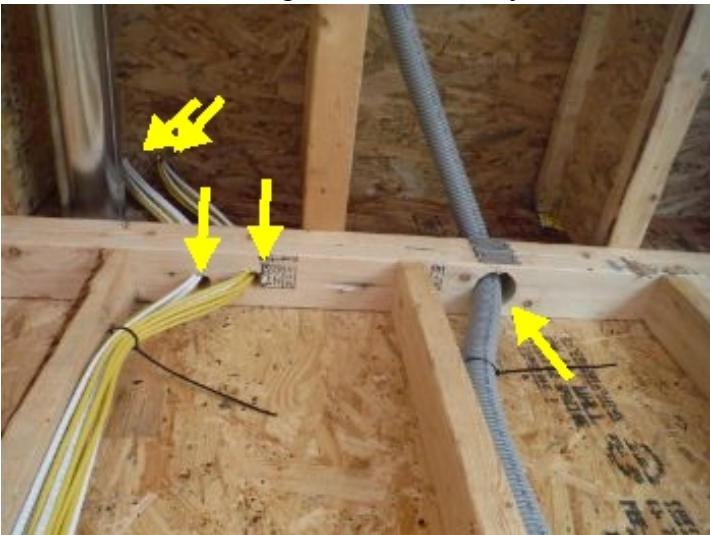
Missing fireblock

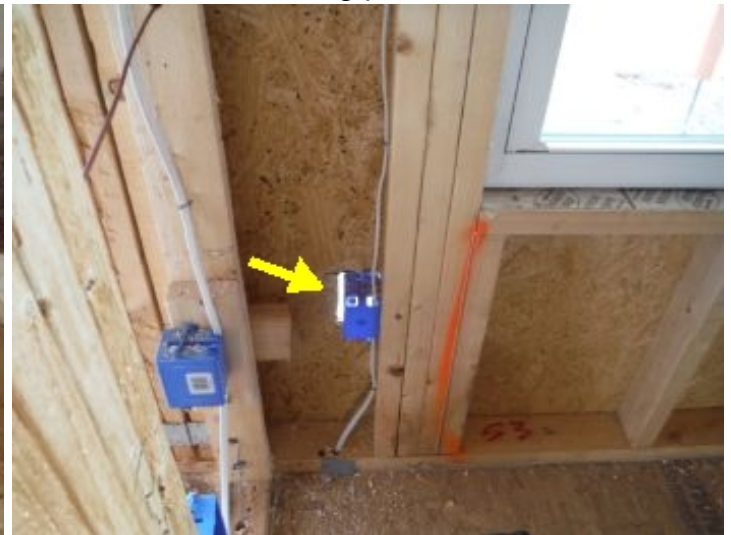
Missing sealant

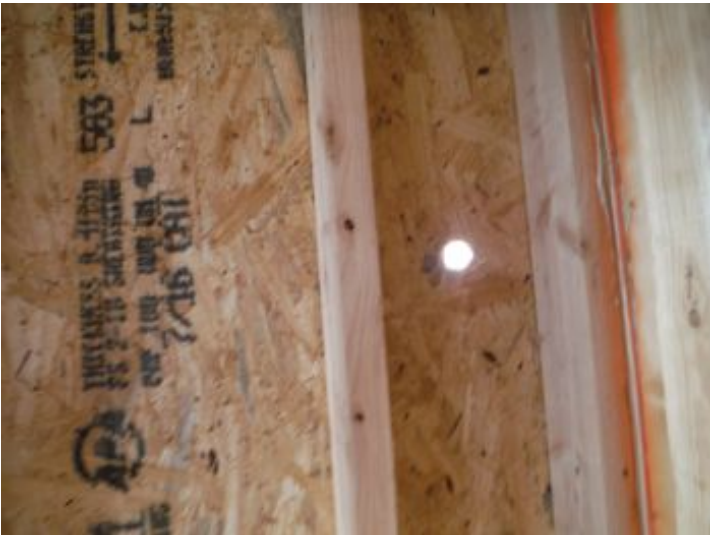
Unused hole in sheathing

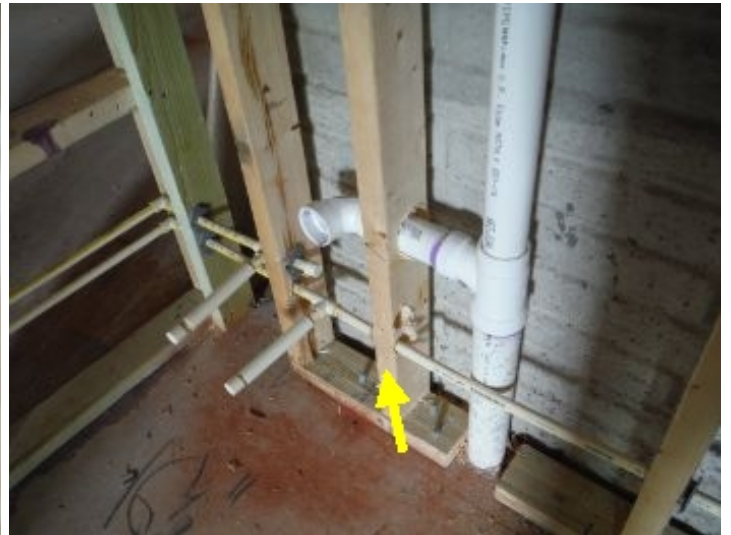
Missing nail plate

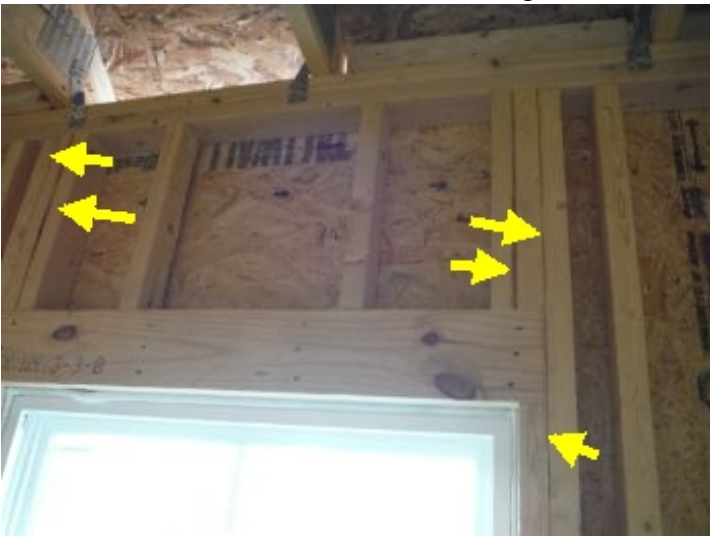
Missing sealant

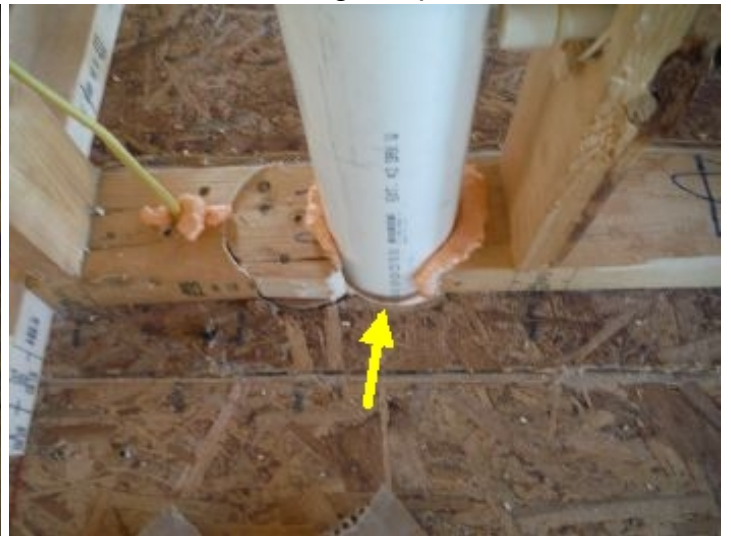
Missing fireblock

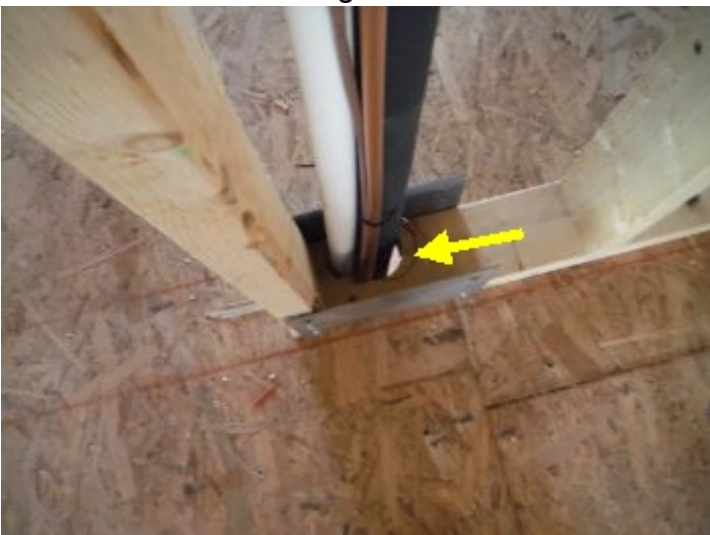
Missing fireblock

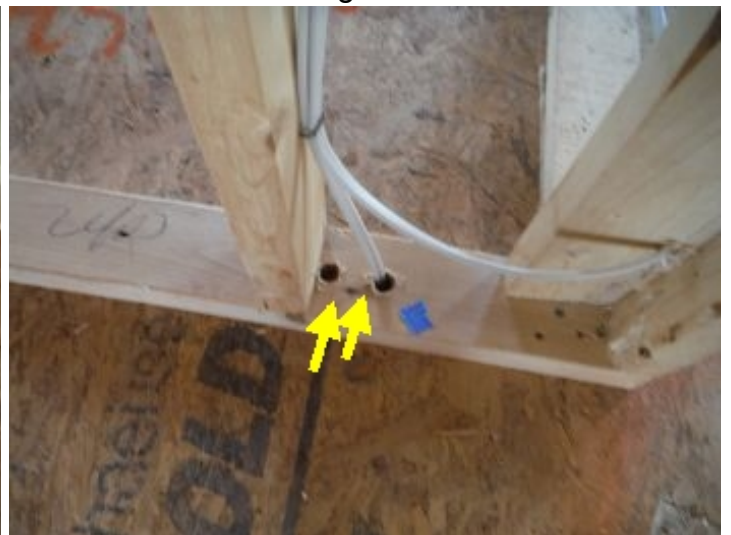
Missing fireblock Primary

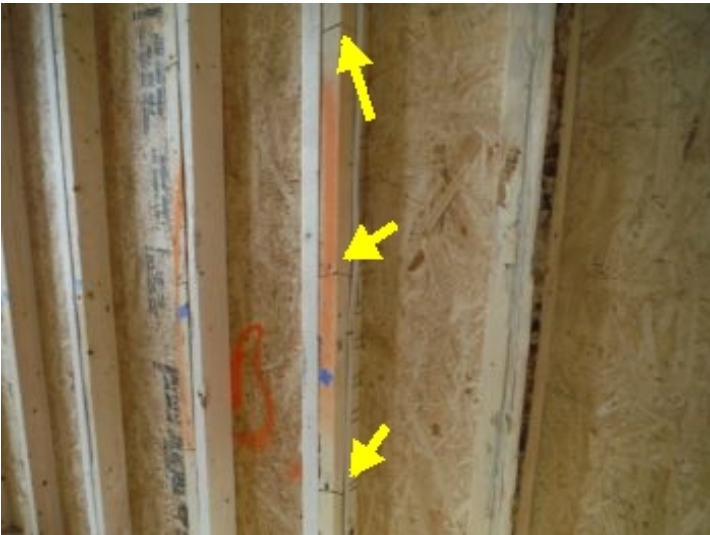
Damaged framing member

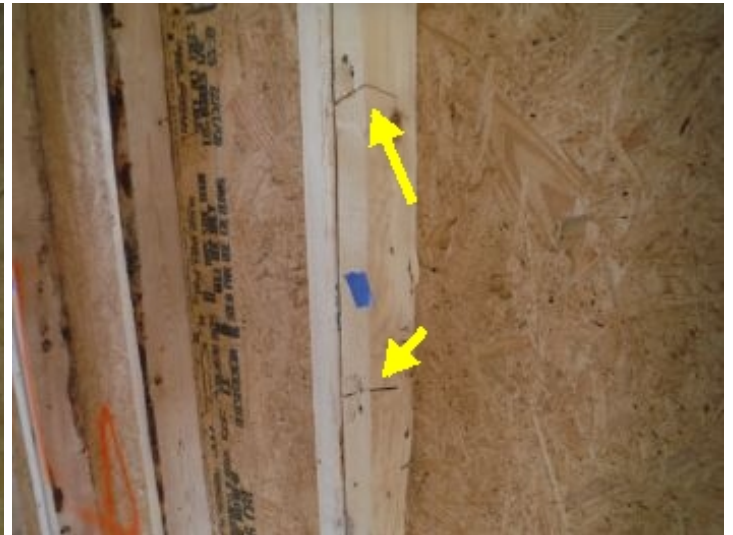
Damaged framing member

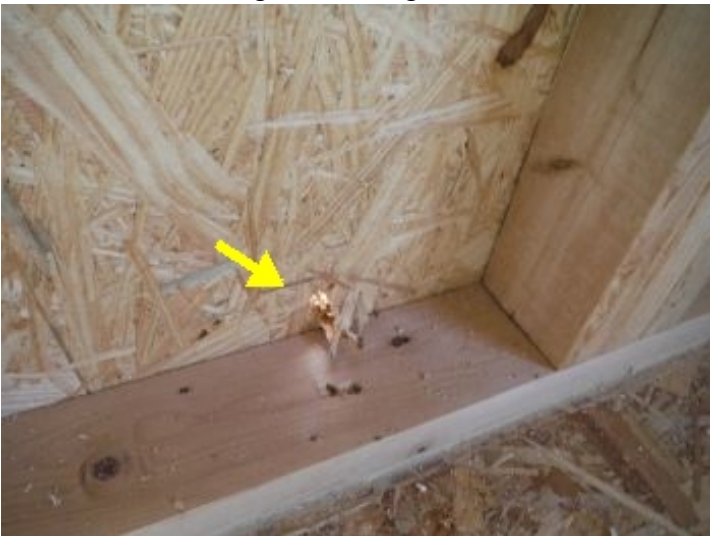
Hole in sheathing

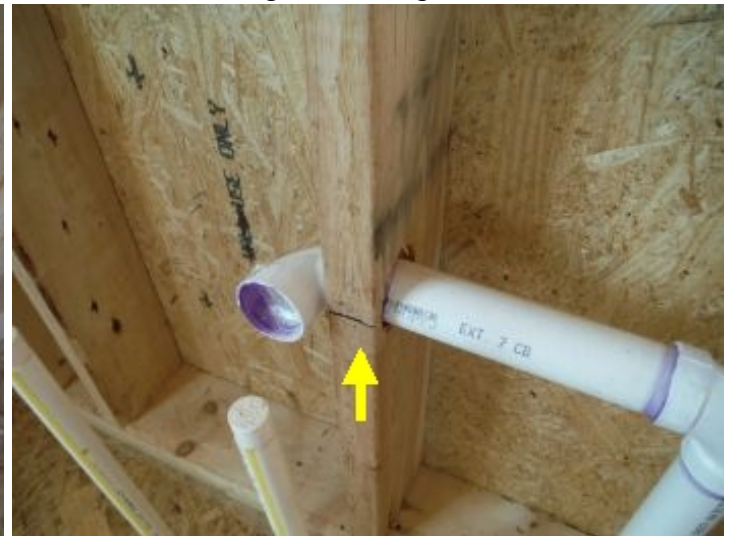
Missing nail plate

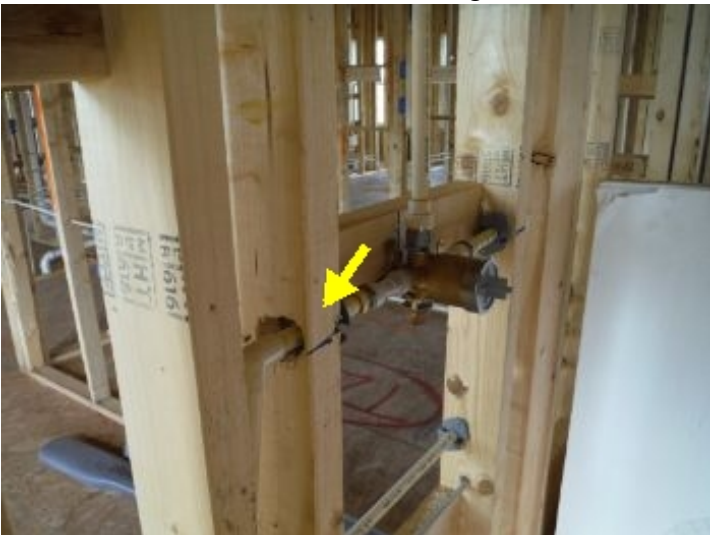
- Hole large. Remaining area of stud is small and weak. Holes in non load bearing studs should be no larger than 60%, load bearing walls 40% the width of the framing member and no closer than 5/8 inch to the edge. Stud shoe, metal strap, or additional framing should be used for additional support.

Hole to close to edge

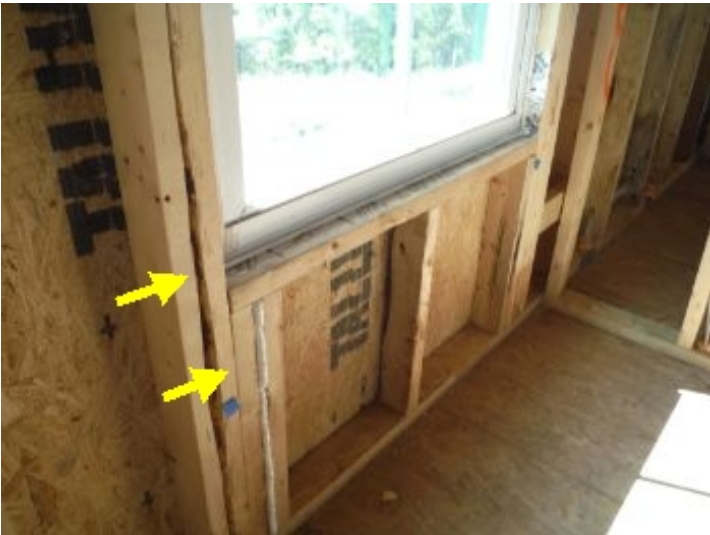
Missing sealant

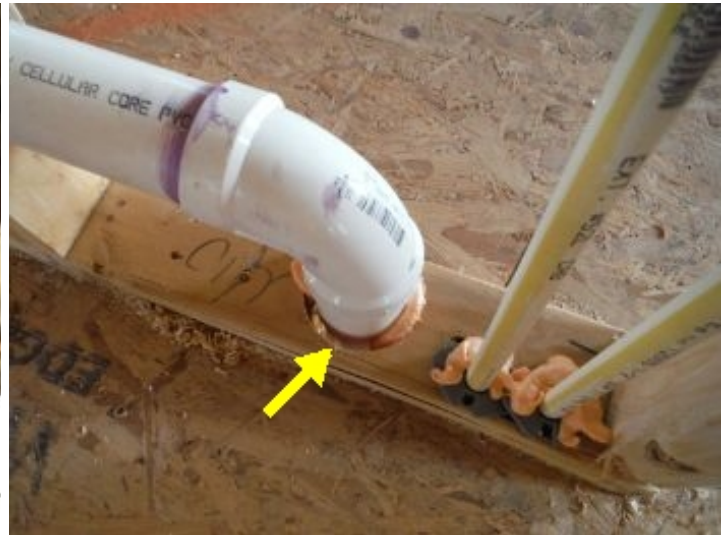
Missing fireblock

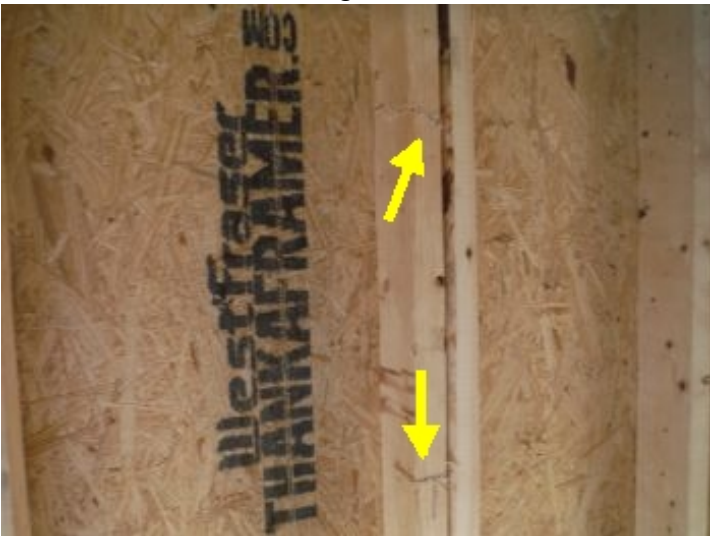
Damaged framing member

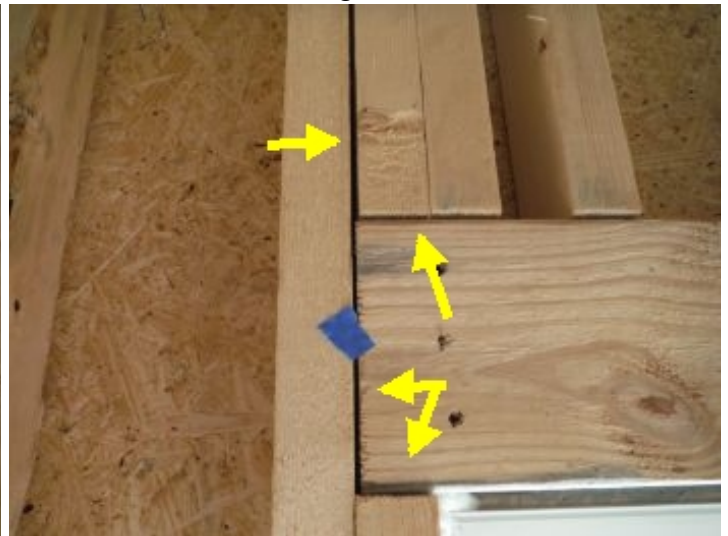
Missing sealant

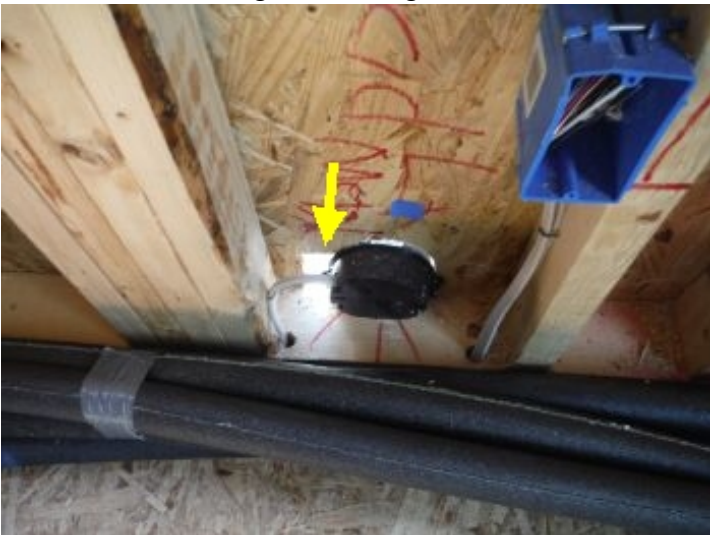
Missing sealant

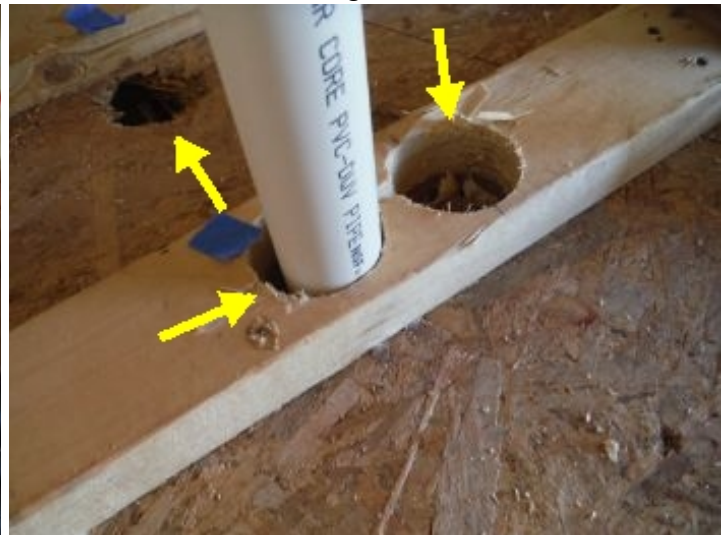
Missing fireblock

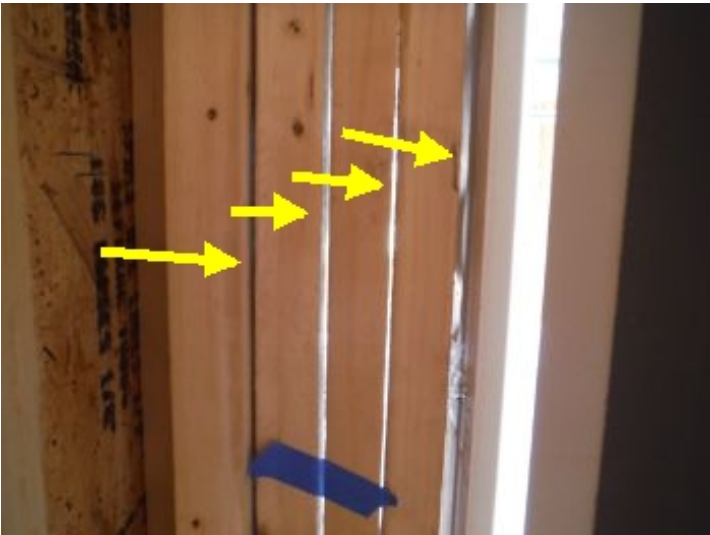
Missing sealant

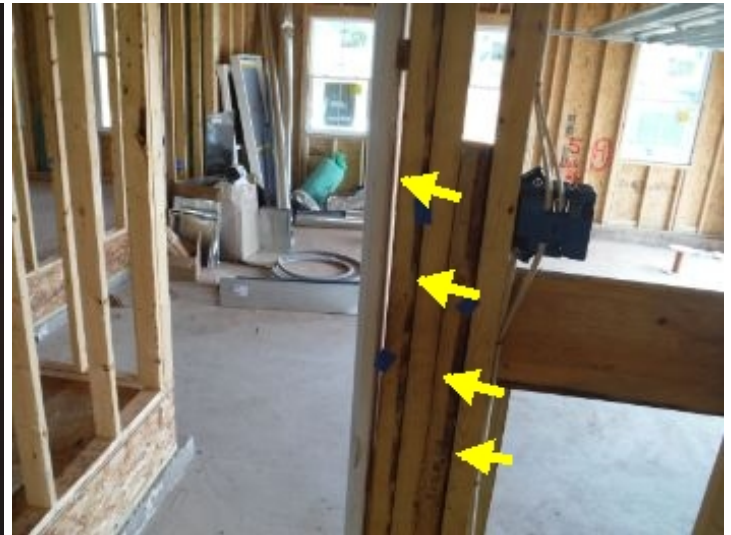
Missing sealant Garage door

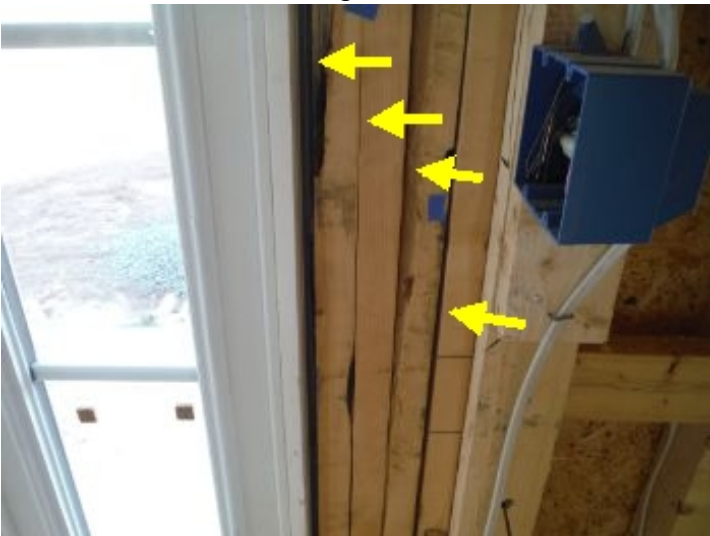
Missing sealant Front door

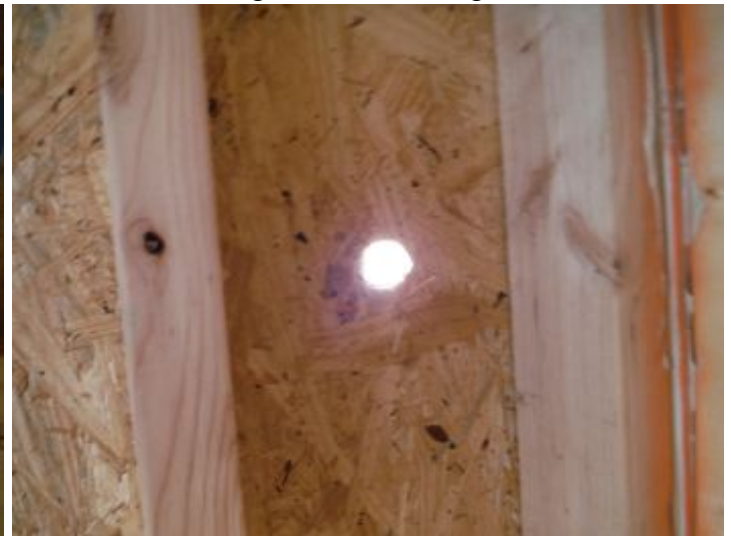
Damaged sheathing

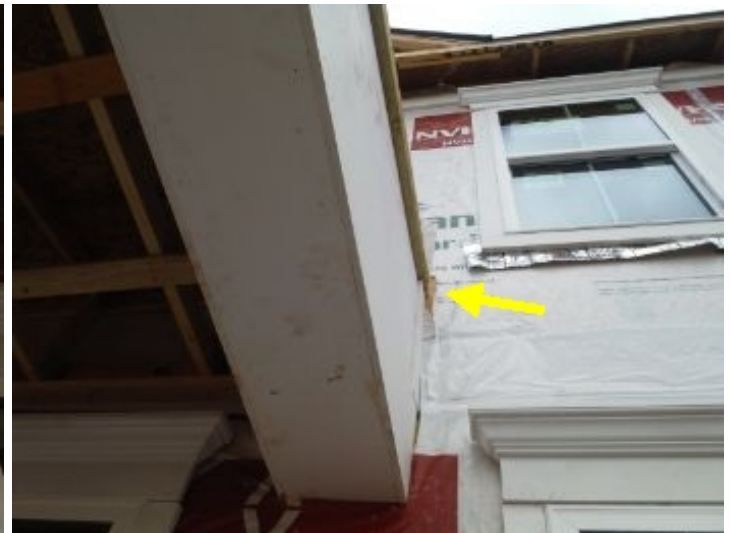
Exposed sheathing

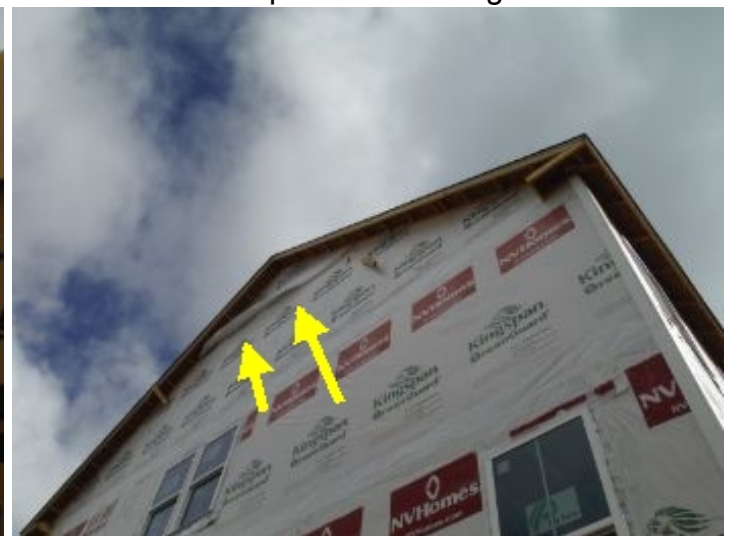
Loose, damaged and/or missing house wrap

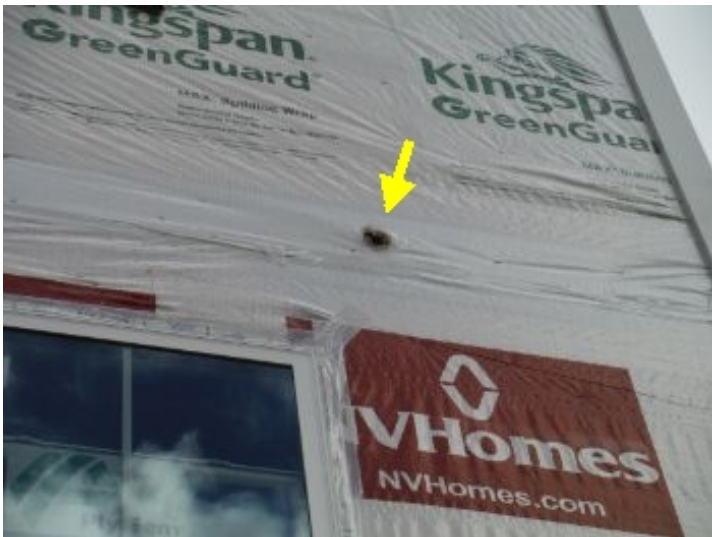
Hole in sheathing

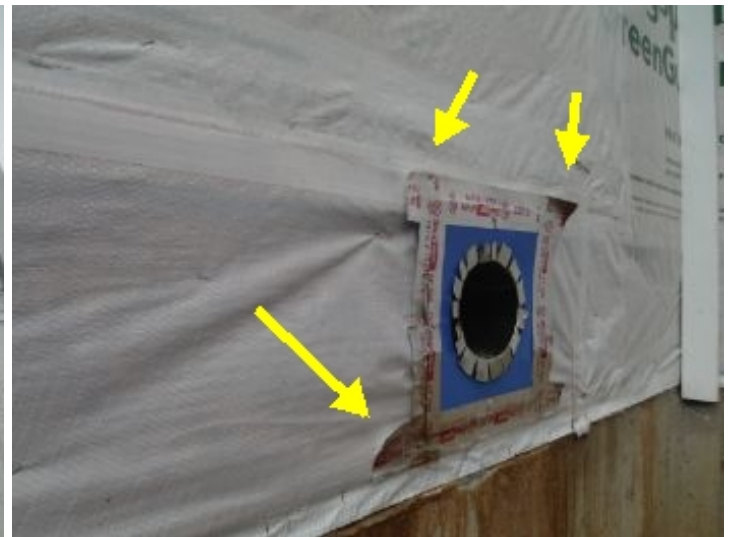
Tape loose

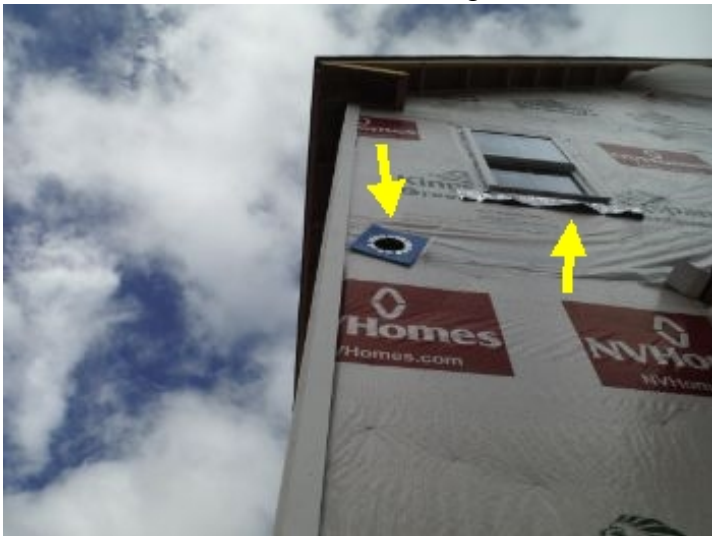
Tape loose and/or missing

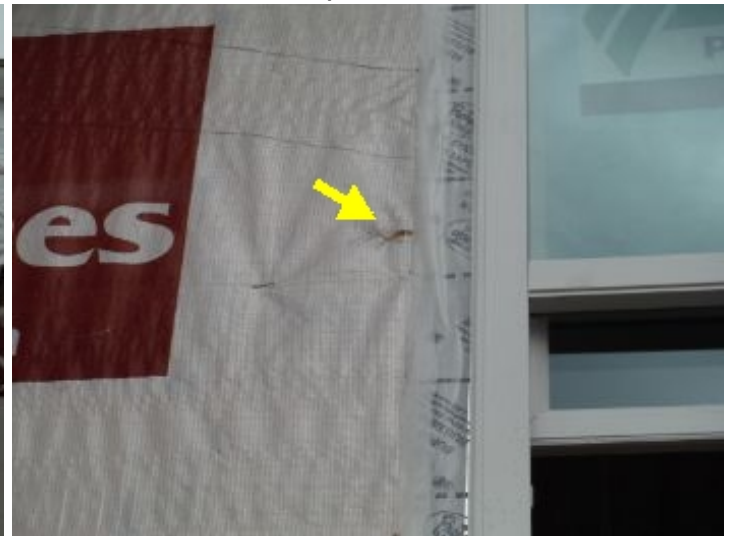
Exposed sheathing

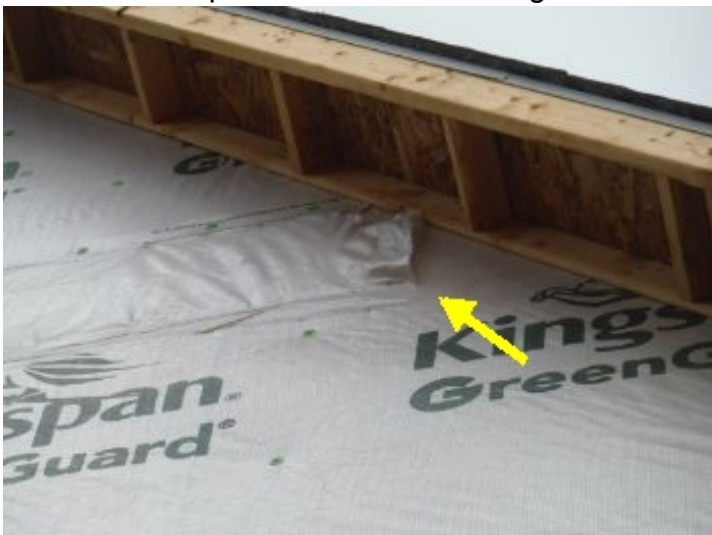
Loose, damaged and/or missing house wrap

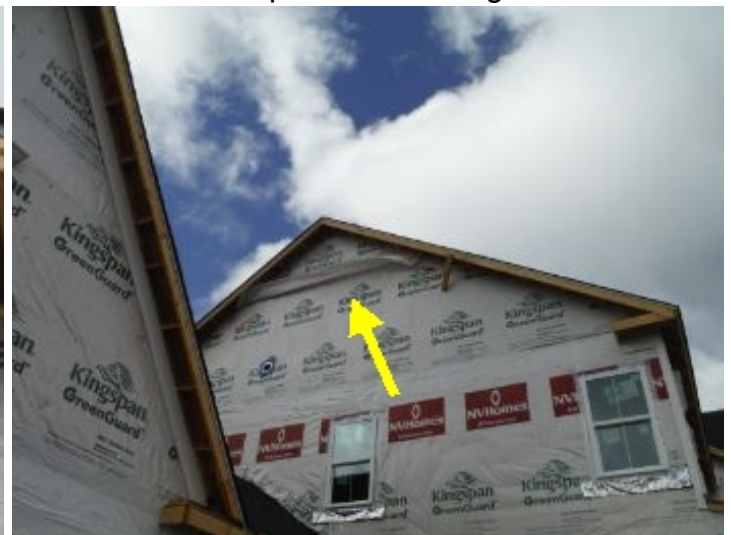
Loose, damaged and/or missing house wrap

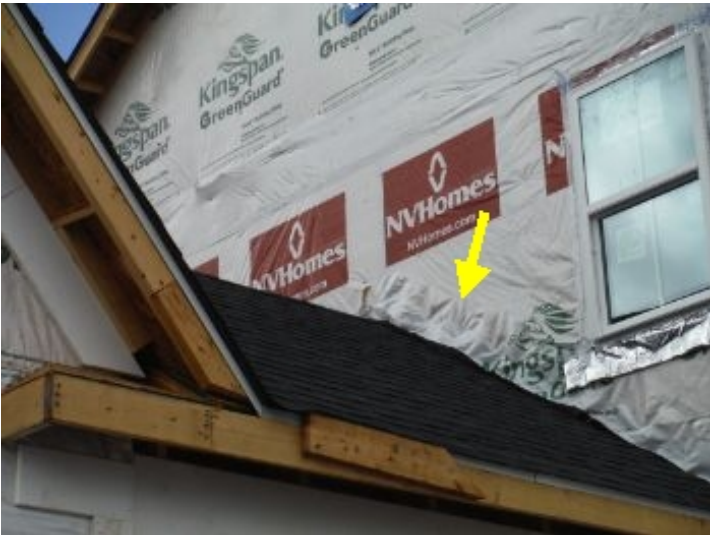
Loose, damaged and/or missing house wrap

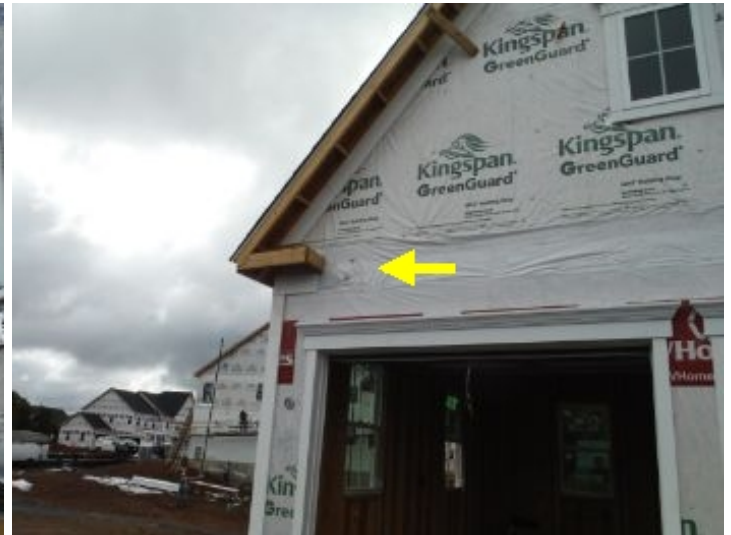
Loose, damaged and/or missing house wrap

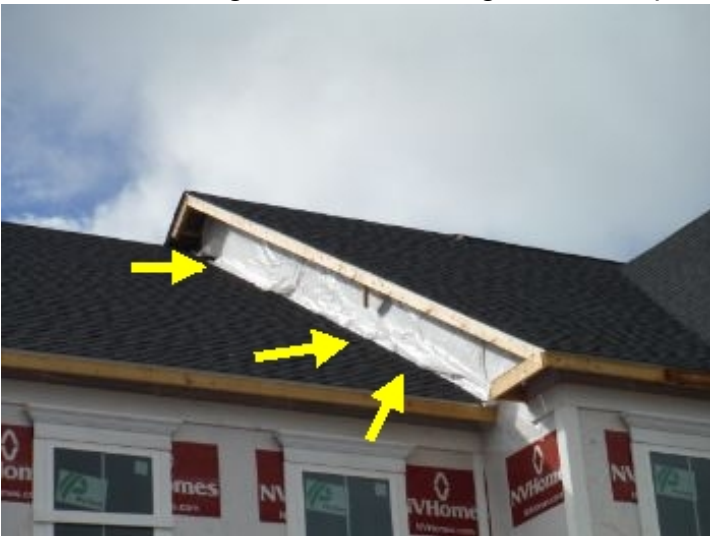
Loose, damaged and/or missing house wrap

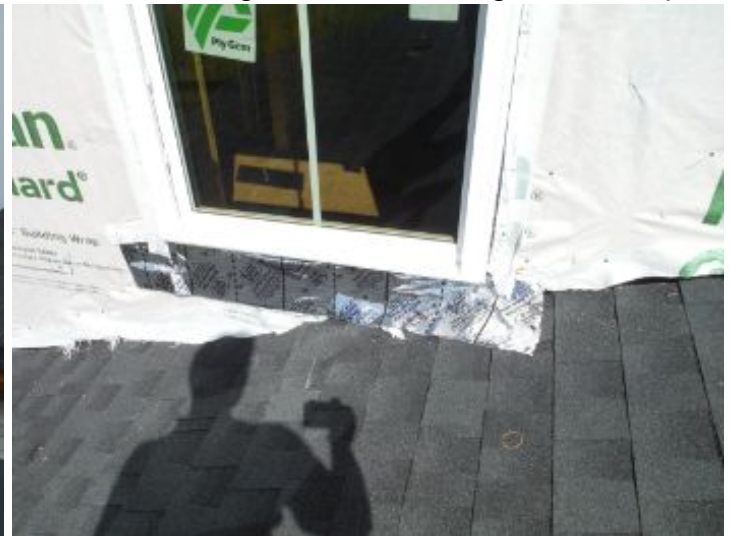
Loose, damaged and/or missing house wrap
