Walker Home Inspection

Property Inspection Report

Your Home , Hometown, VA
Inspection prepared for: Sample Report
Date of Inspection: 9/6/2022 Time: 9:45-12:30 pm Size: 5000 sqft
Weather: Recent rain

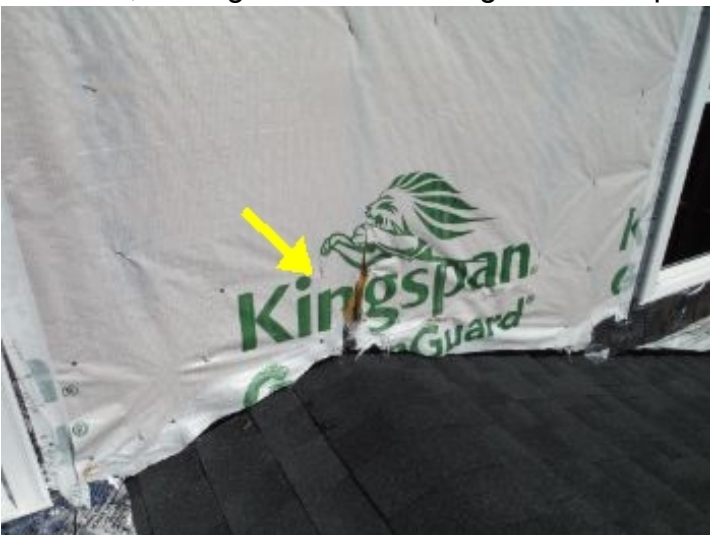
Loose, damaged and/or missing house wrap

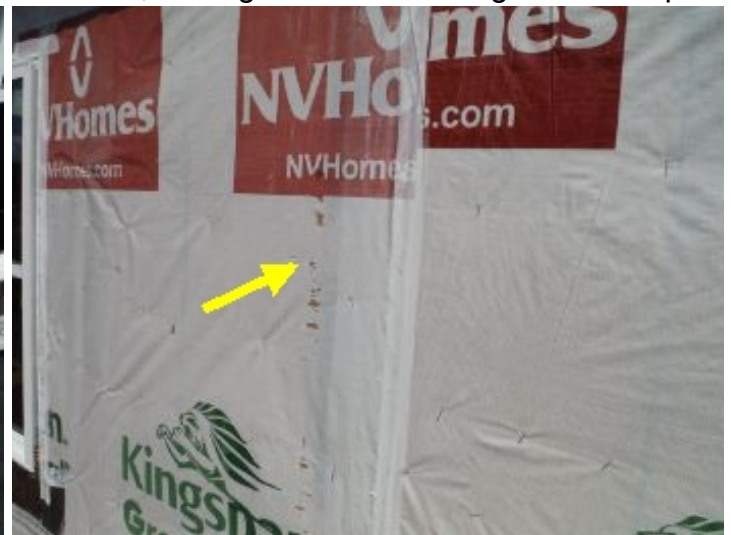
Tape loose and/or missing

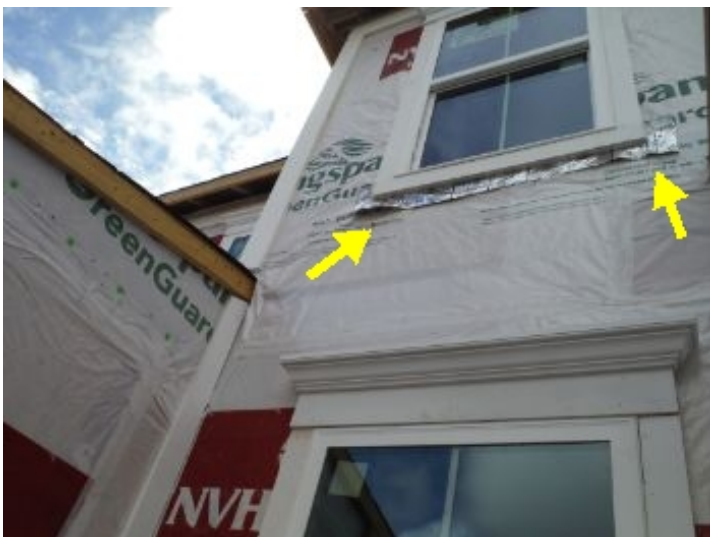
- Loose flashing tape: All flashing should be properly taped to house wrap to prevent moisture intrusion and/or damage. Recommend correction.
- Flashing not visible and/or missing. All penetrations require flashing to carry water to exterior or to water-restive membrane. Recommend installation.

Tape loose

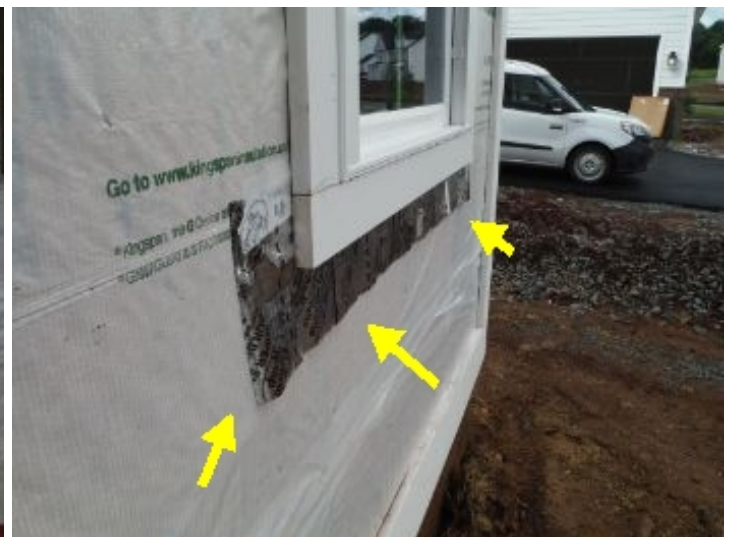
Tape loose

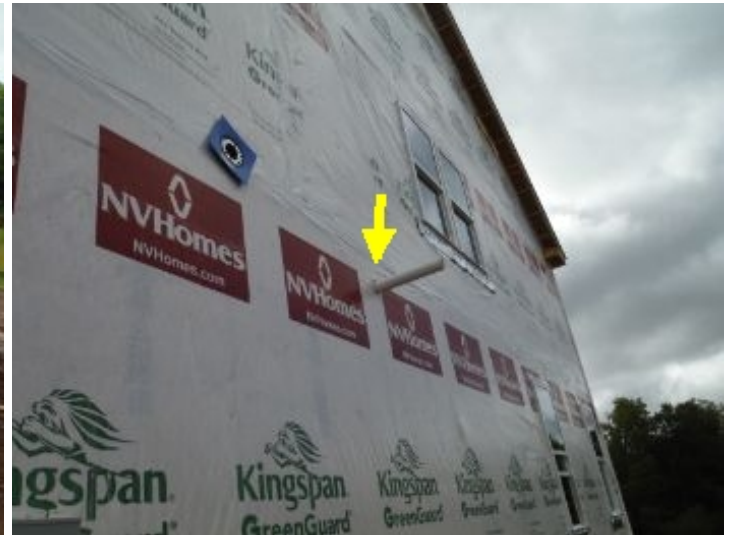
Flashing Missing

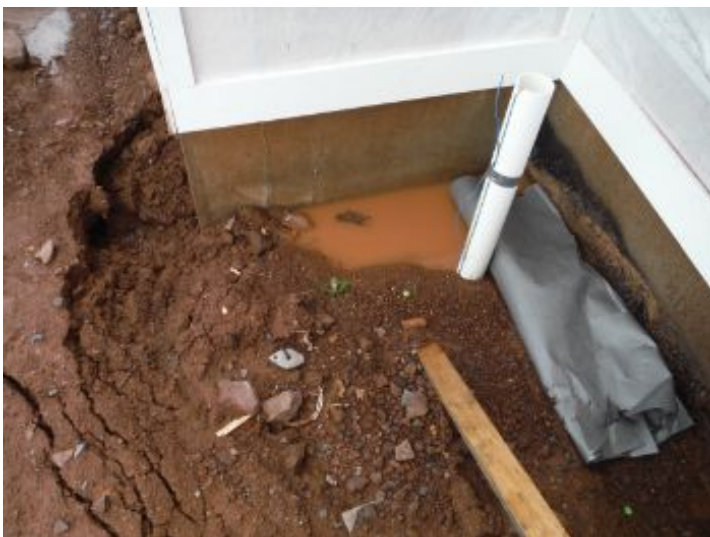
- Low area. Repair. Recommend adding additional back fill to prevent water from pooling and draining to foundation wall.

Low area

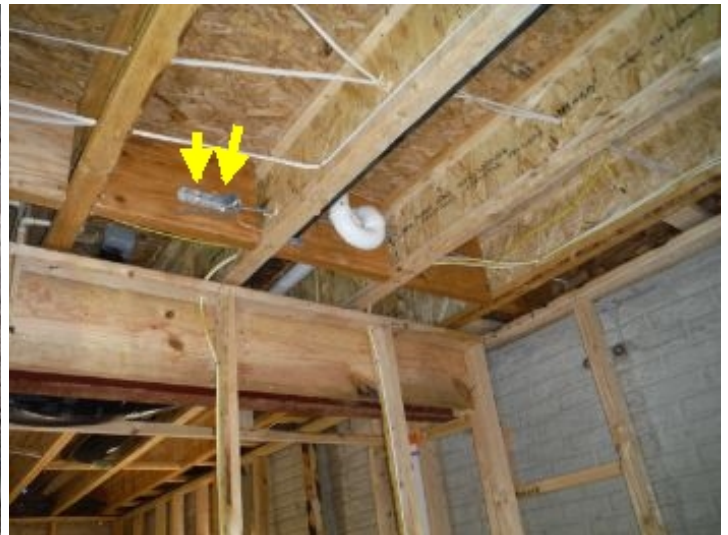
- Missing fastener(s): All round hole(s) in connectors should be filled by appropriate fastener. Recommend additional fastener to ensure proper strength.

Loose and missing fastener

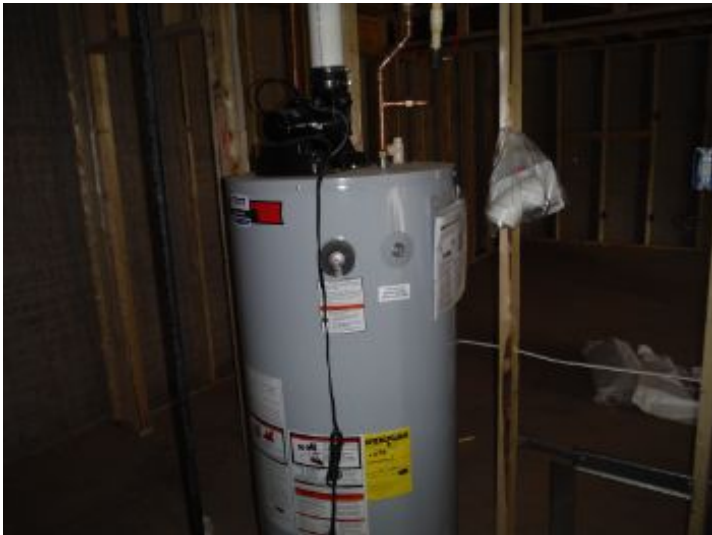
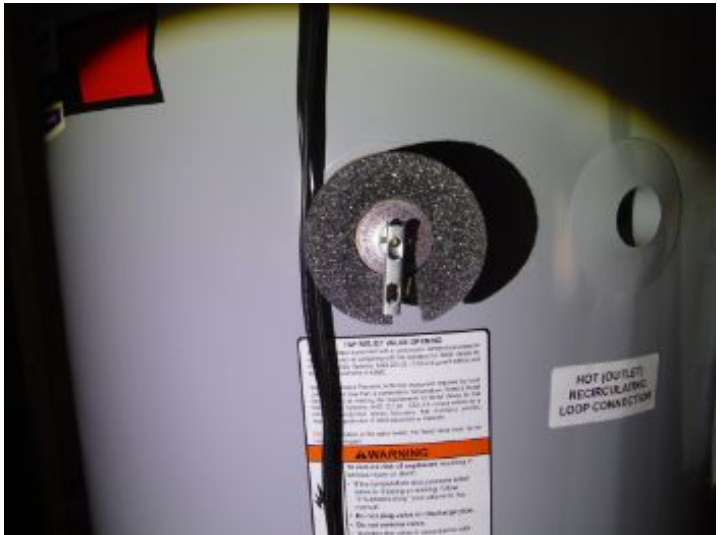
- Missing support straps: Recommend correction. Install support straps to secure **expansion tank**.
- TPR drain line not installed. Recommend installation.

TPR valve line missing

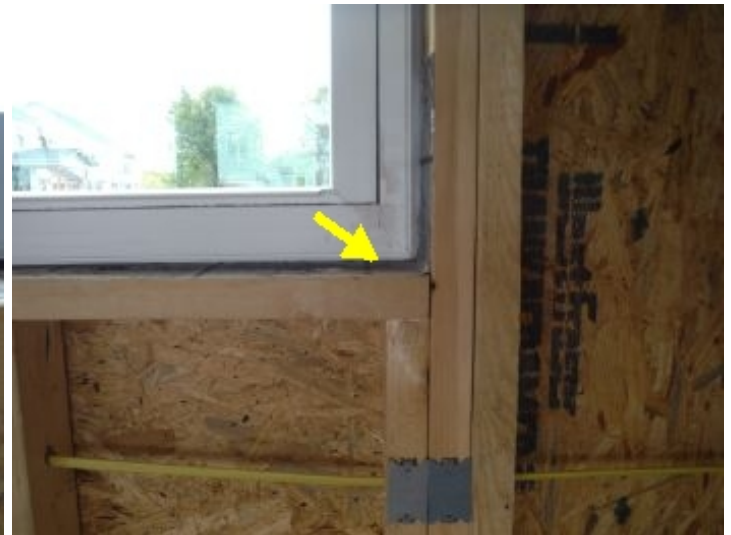
- Window shims missing: Recommend installation: Prevent damage to window(s) install window shims under all vertical window jambs. Have windows properly shimmed before sealant is installed.

Missing shims

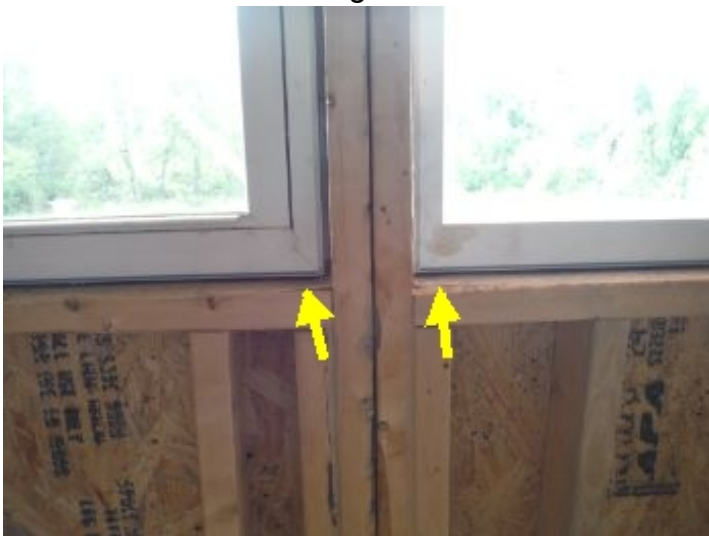
Missing shims

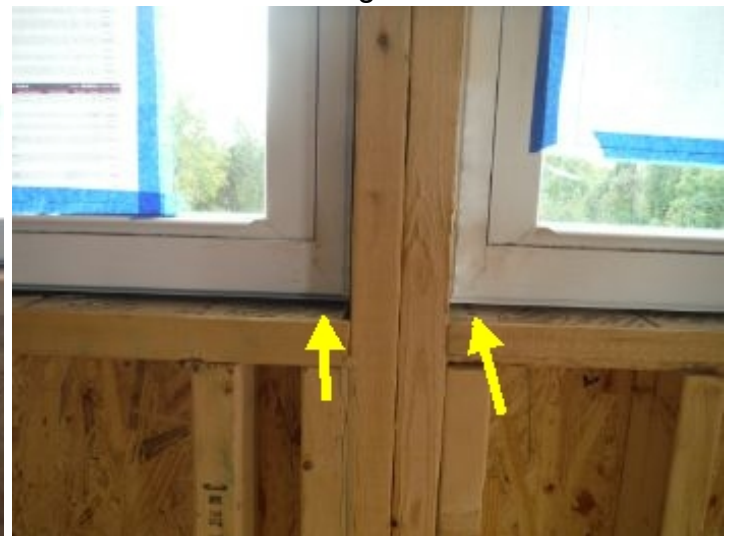
Missing shims
