Walker Home Inspections

Your Property Inspection Report

Date of Inspection: 1/5/2026 Time: 10:30 - 1:30 pm
Age of Home: 2016 Size: 5800 sq ft

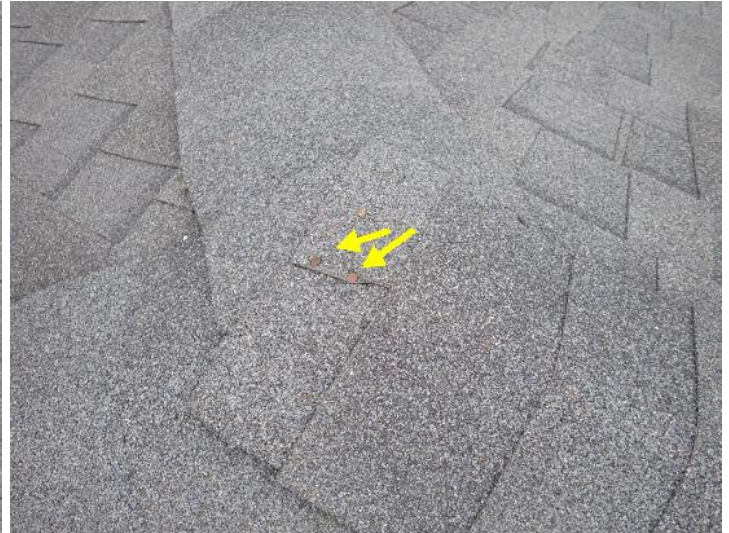
Exposed fasteners

- Exposed fastener(s). Prevent leaks or water damage. Seal all exposed nail heads and roof flashing. Recommend roofing sealant such as Loctite PL S30 or Liquid Nails RR-808. Replace loose, rusted, or short nails.

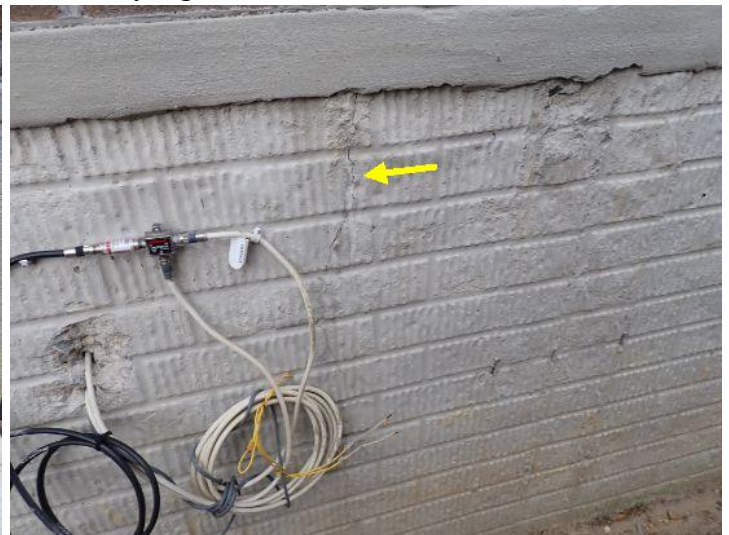
- Cracks / Holes (1/4" or less) present in: foundation / floor / ext. wall. Recommend ensuring cracks are sealed to prevent water infiltration and damage from freeze and thaw cycles. Generally speaking, cracks that are less than 1/4" are not commonly regarded as being structurally significant.

Crack visible Left side

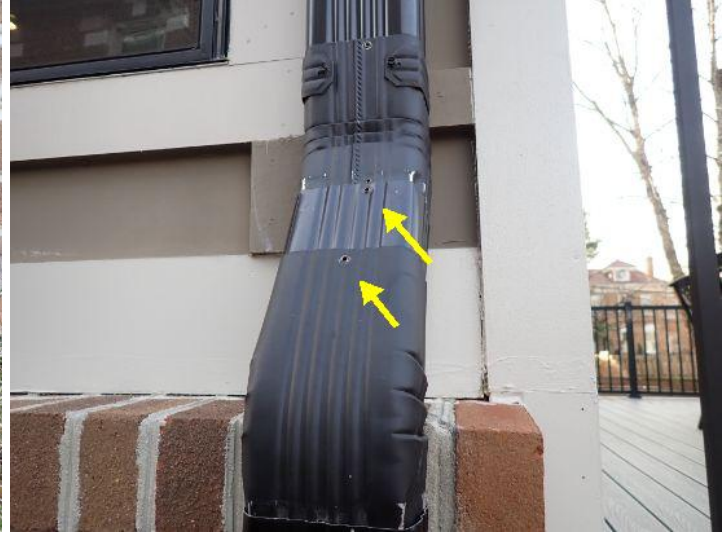
Missing fasteners

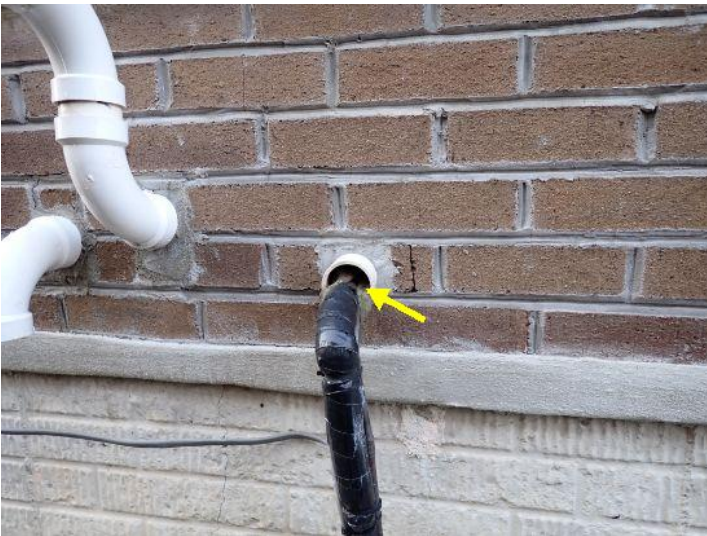
Failed or Missing sealant

- One or more areas of missing, failed or poorly applied sealant. All instances of missing, failed, or improperly applied sealant should be identified and addressed. All gaps should be located and filled with the appropriate sealant to effectively prevent water intrusion and pest infestation.

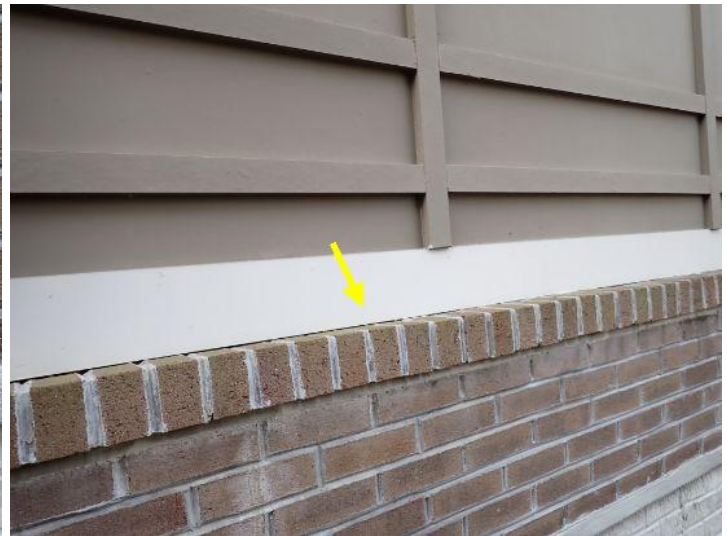
Missing flashing

- Missing flashing: Missing flashing observed in one or more areas, or existing flashing appears improperly installed. Refer to the manufacturer's installation specifications for proper compliance, as improper installation may void the product warranty.

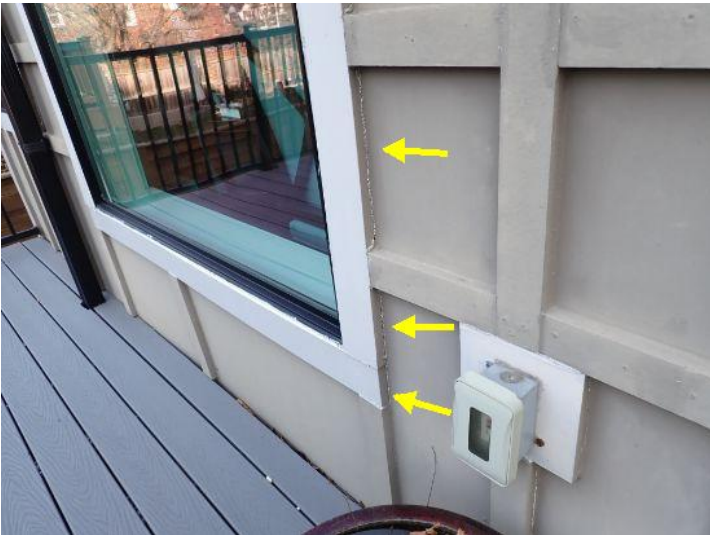
Failed or Missing sealant

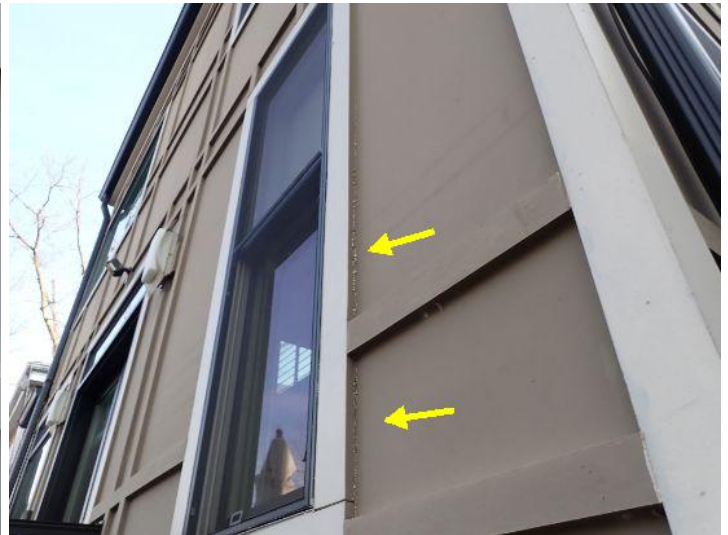
Failed or Missing sealant Rear

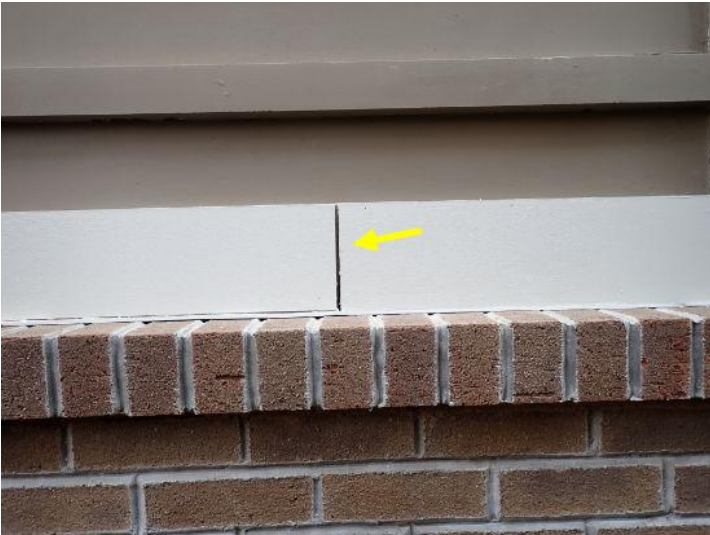
Failed or Missing sealant

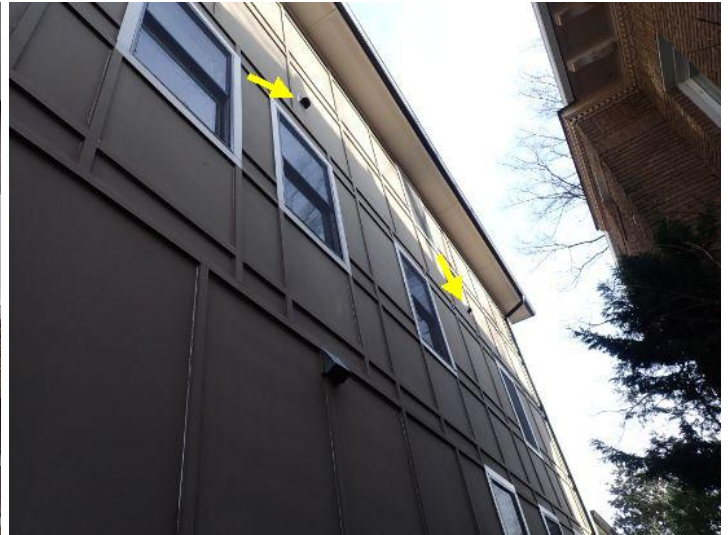
Penetration block missing/not visible

- Missing penetration block. One or more instances of missing penetration blocks. For penetrations in the building envelope such as hose bibs and holes 1½ in diameter or larger, such as dryer vents, a block of HardieTrim® 5/4, 4/4 boards shall be installed around the point of penetration. Blocking should be a minimum 3 in radius greater than the radius of the penetration.

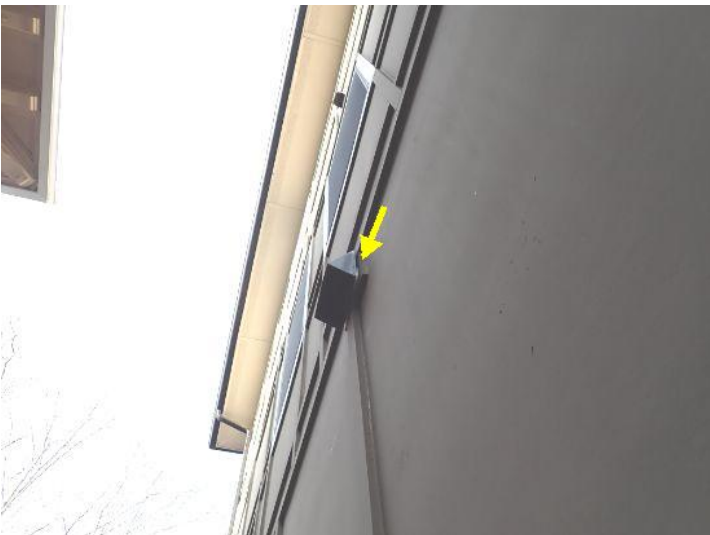
Failed or Missing sealant

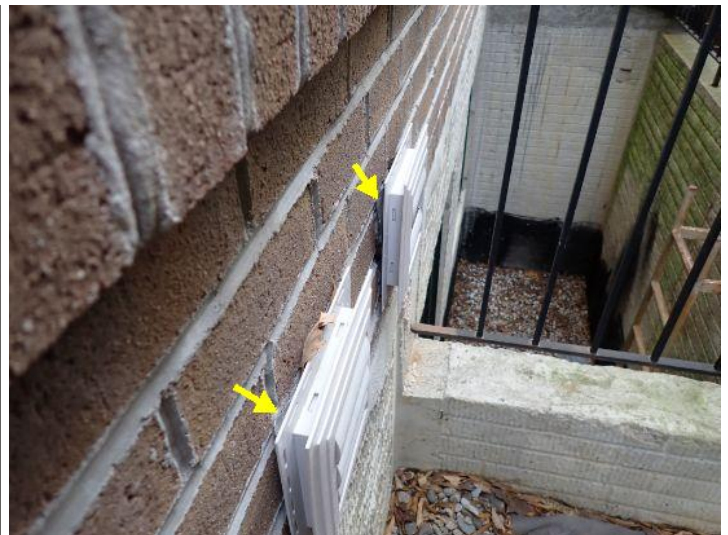
Failed or Missing sealant

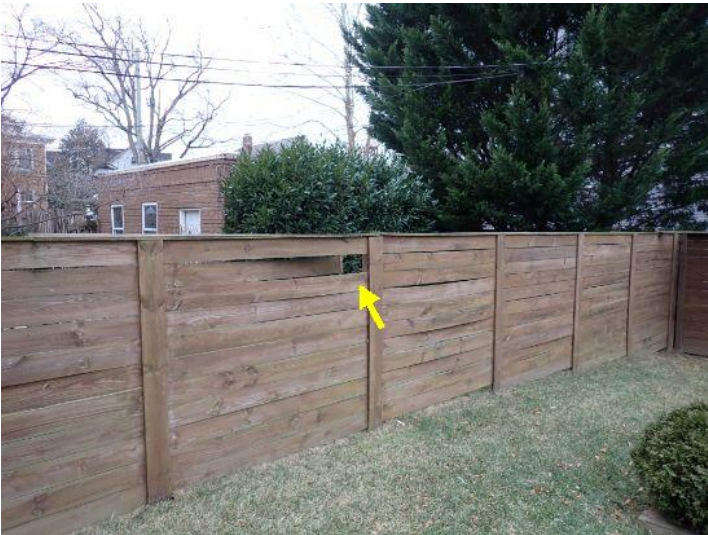
Loose board

- Loose or warped fence boards observed in one or more areas. Correct as needed to prevent further deterioration and maintain a more finished appearance.

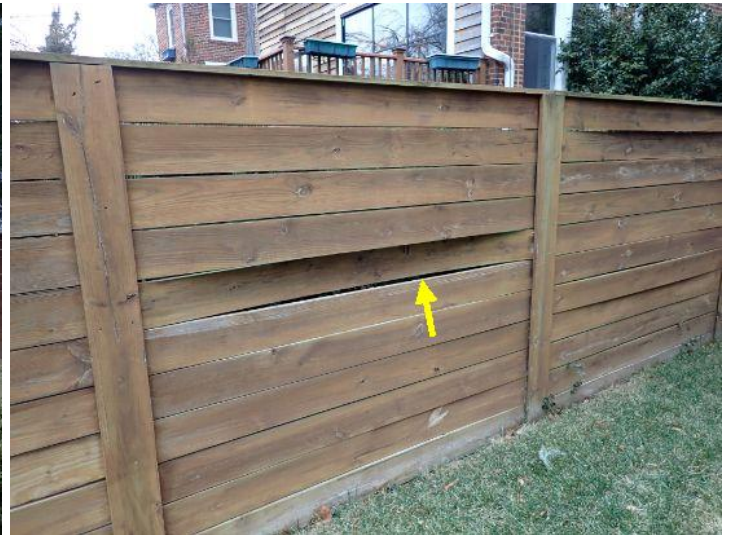
Loose board

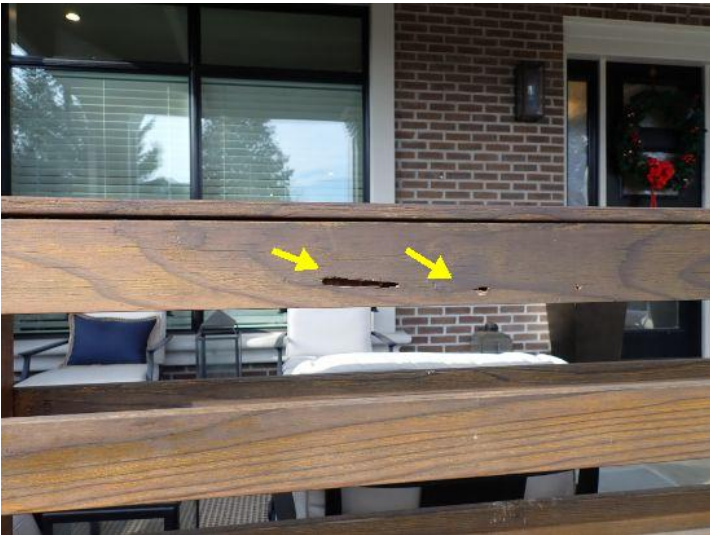
Damaged Carpenter Bee

- Possible carpenter bee damage. Carpenter bees can cause significant damage to wood structures and weaken framing members over time. Recommend further evaluation.

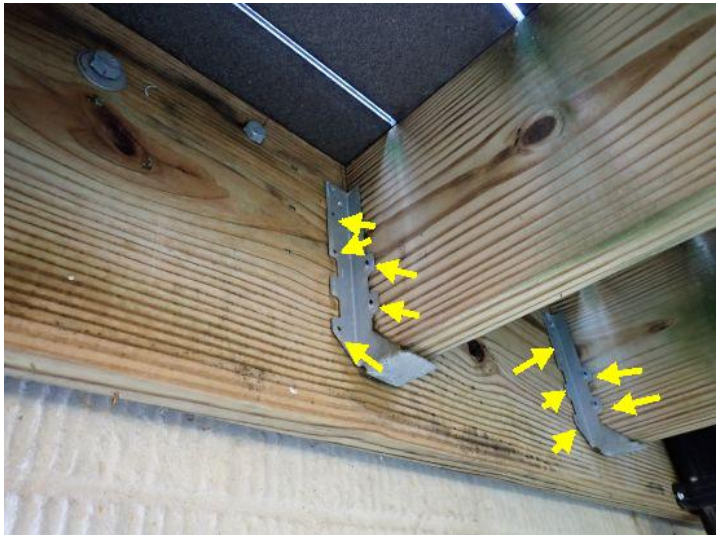
Missing fasteners

- Loose or Disconnected Fasteners: Fasteners were observed to be loose, missing, or improperly secured in various locations. This condition can lead to reduced structural stability, component failure, or material displacement over time. Recommendation: Re-secure or replace all loose or disconnected fasteners using appropriate materials and torque specifications. Ensuring secure connections helps maintain the integrity and safety of the assembly and prevents damage or loss of components.

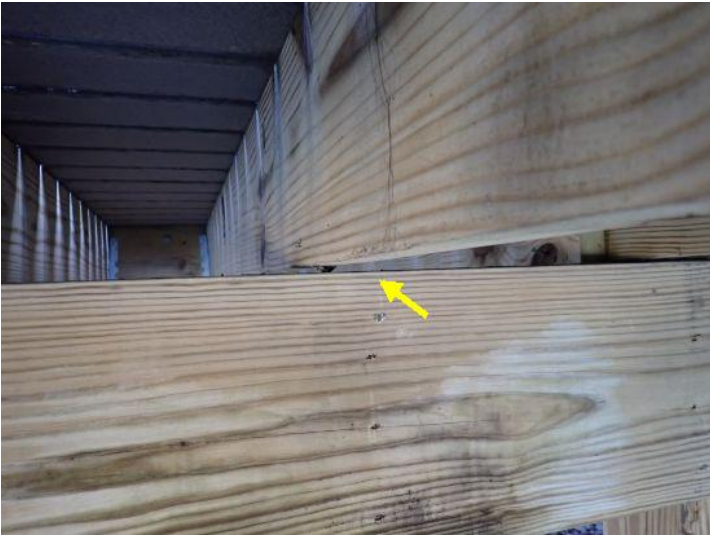
Missing bearing

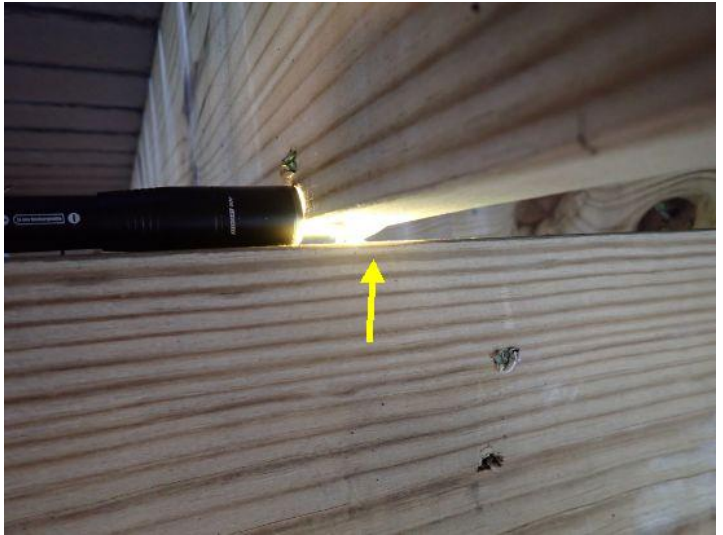
Missing bearing

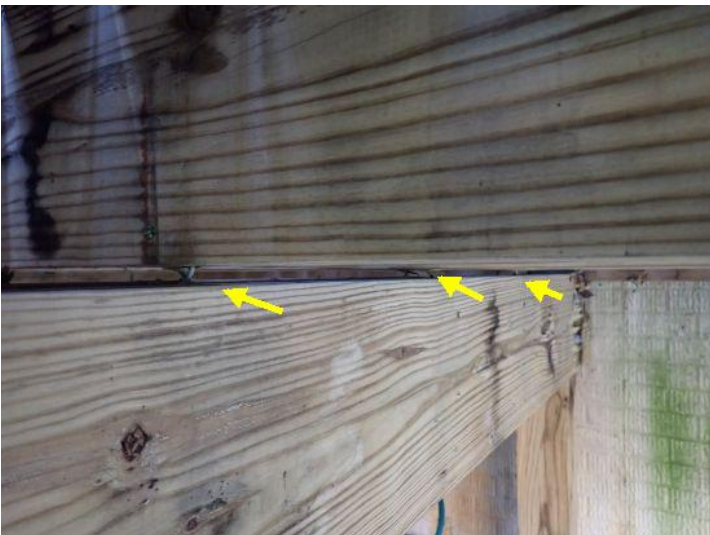
Missing bearing

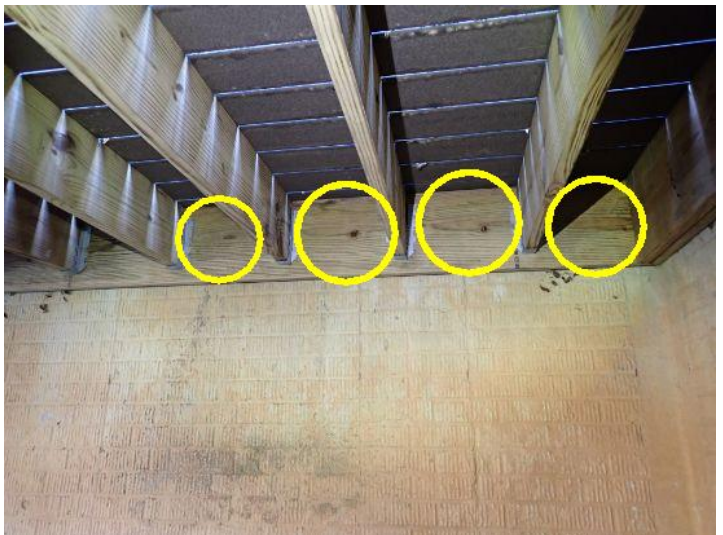
Missing fasteners

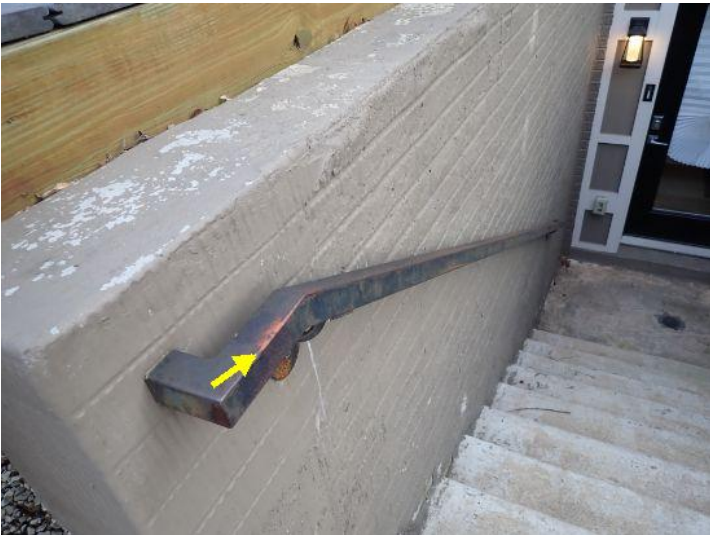
Rust visible

- Rust visible. Rust Identified on Metal Components: Areas of visible rust were observed on exposed metal surfaces. Rust not only compromises the appearance of the structure but, if left untreated, can lead to material degradation and weakened structural integrity. Recommendation: Remove any loose or flaking rust with appropriate tools (e.g., wire brush or grinder), then clean the surface thoroughly. Apply a rust-inhibitive metal primer or rust converter, followed by exterior-grade paint designed for metal surfaces. For any post penetrations into masonry or concrete, seal and level using anchoring cement to ensure long-term durability and a secure bond.

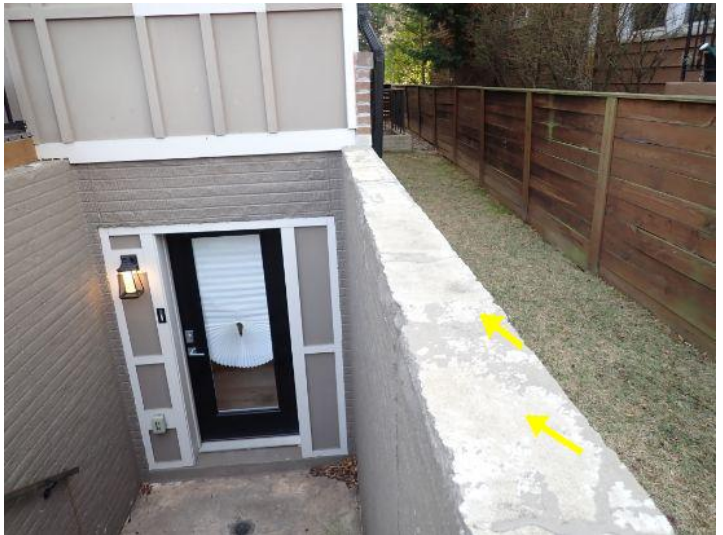
Failed or missing paint

- Failed paint. Recommend removing all failed paint. Prime and paint all necessary areas to prevent further damage and present a more finished look.

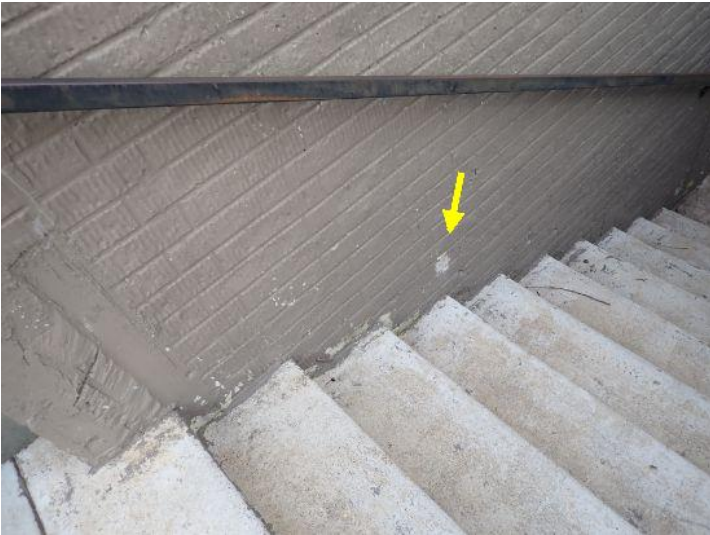
Failed or missing paint

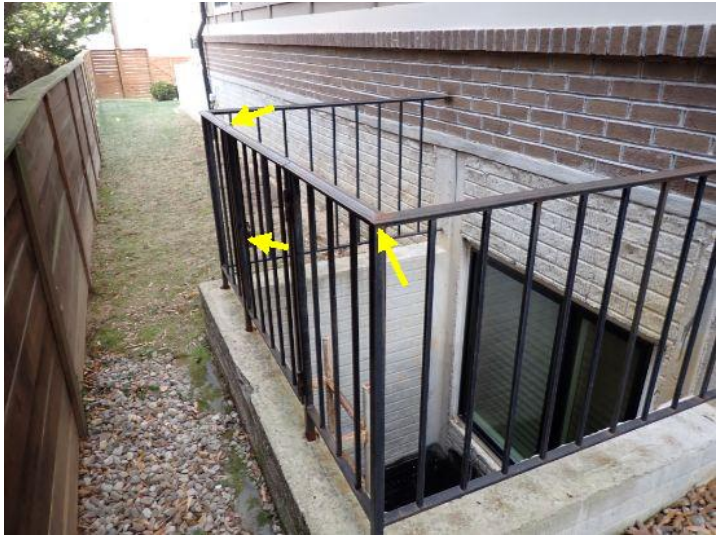
Rust visible

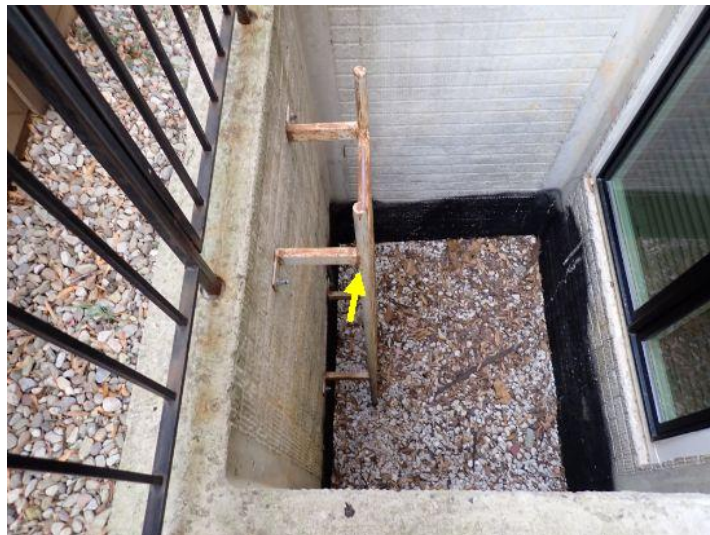
Rust visible

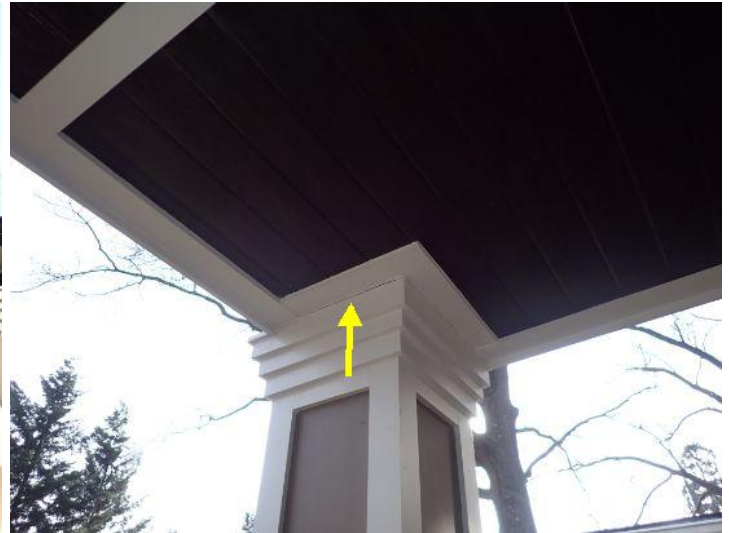
Failed or Missing sealant

- One or more areas of failed or missing paint/sealant. Identify all instances for correction, though not every occurrence may be documented.

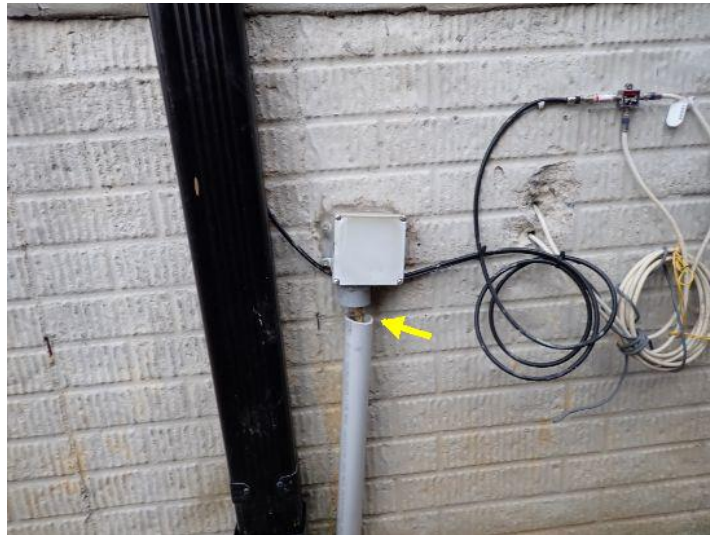
Damaged conduit

- Loose or disconnected conduit. Recommend ensuring no gaps are accessible to prevent access to live electrical components.

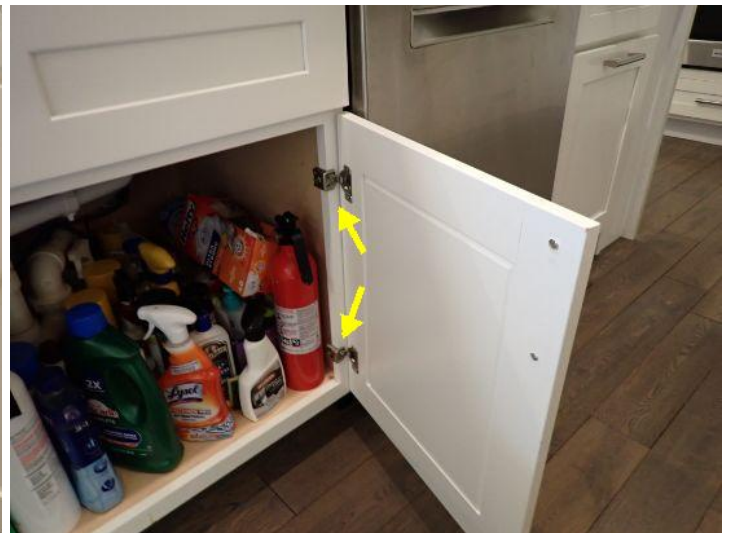
Loose hardware.

- Loose hardware: Prevent damage or injury. Ensure all hinges are secure. Stripped holes may need longer screws or may need to be filled with glue and wooden dowels or matches and re-drilled before reinstalling screws. Align cabinet doors squarely and evenly with the position of the hinges.

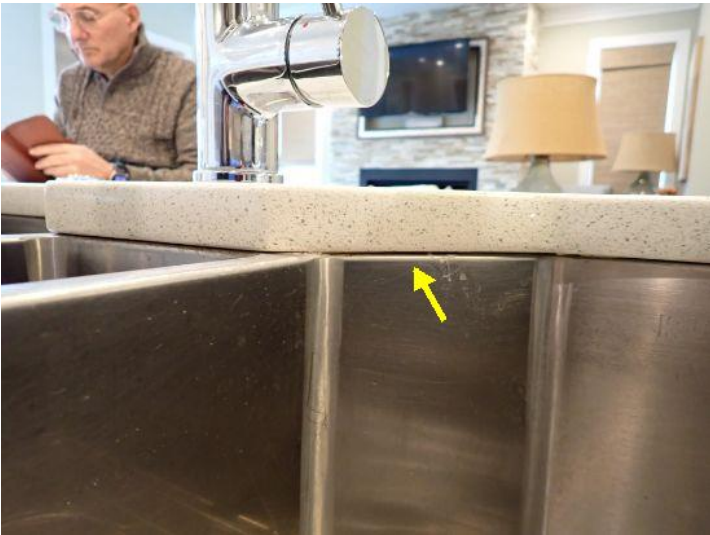
Failed or missing sealant

- Caulk is failed or missing. Repair to prevent water damage, pest intrusion, and organic growth. Recommend caulking the entire length of the sink-to-countertop junction.

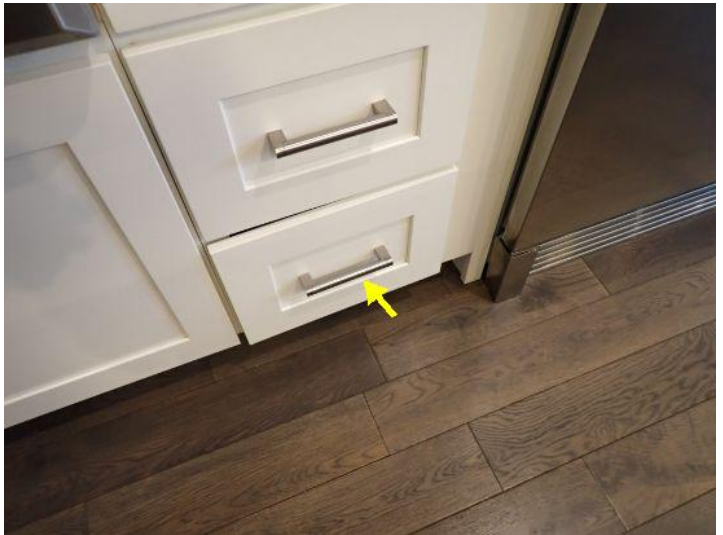
Loose hardware.

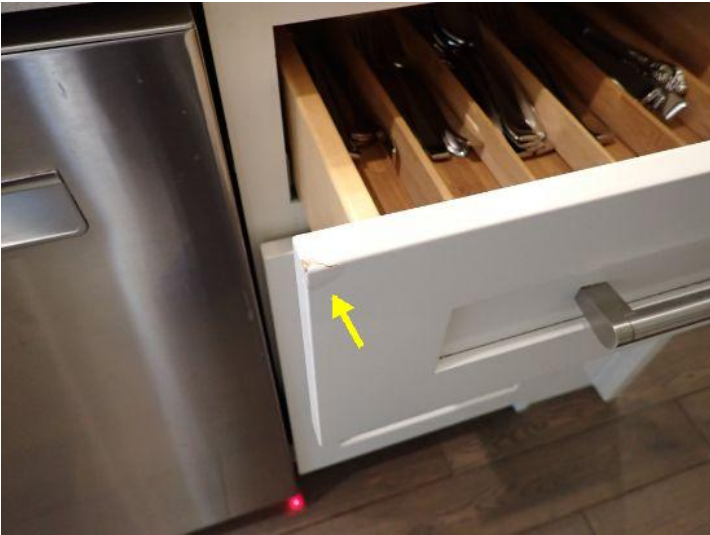
Damaged

- Cabinet and/or cabinet door(s) damaged or missing noted. Recommend repair to ensure proper function and a finished look.

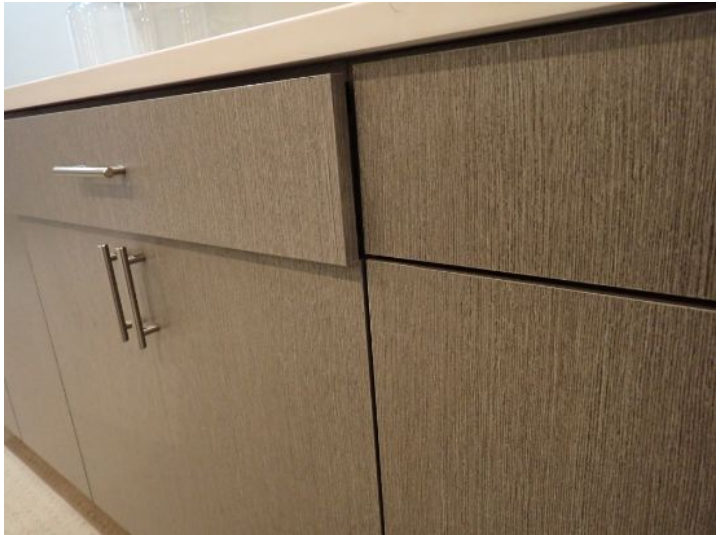
Cabinet/Drawer door misaligned Basement bar

- Misaligned Cabinet or Drawer Door: One or more cabinet or drawer doors were observed to be misaligned, resulting in uneven gaps, improper closure, or friction during use. Misalignment can lead to premature wear on hinges and adjacent surfaces, potentially reducing the lifespan and functionality of the cabinetry. Recommendation: Adjust doors and drawer fronts as needed to ensure proper alignment and smooth operation. Correct positioning helps prevent damage, promotes ease of use, and restores the intended aesthetic of the cabinetry.

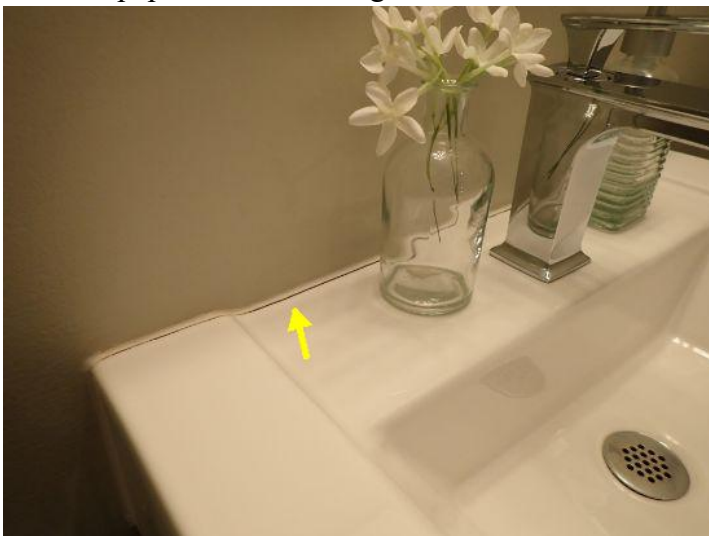
Failed and/or Missing sealant Half bath

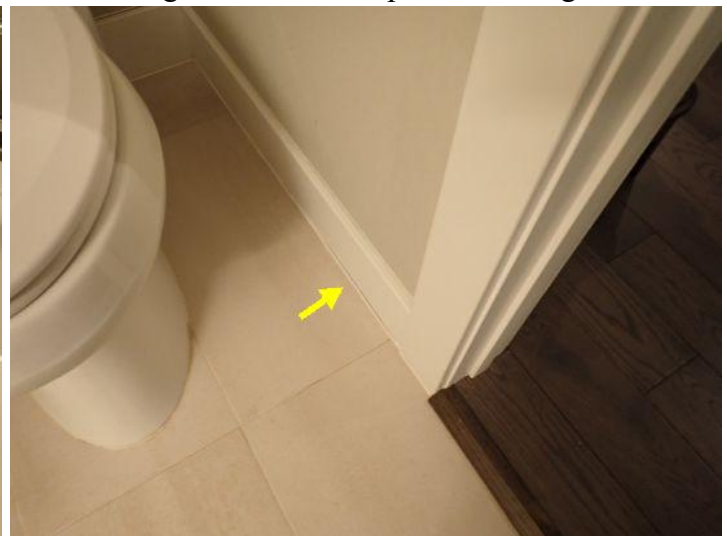
Failed and/or Missing sealant Basement on suit bath

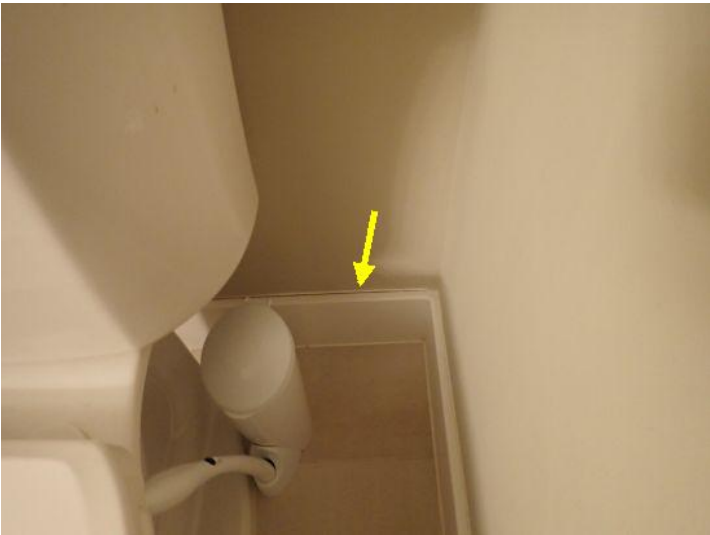
Failed and/or Missing sealant Basement on suit bath

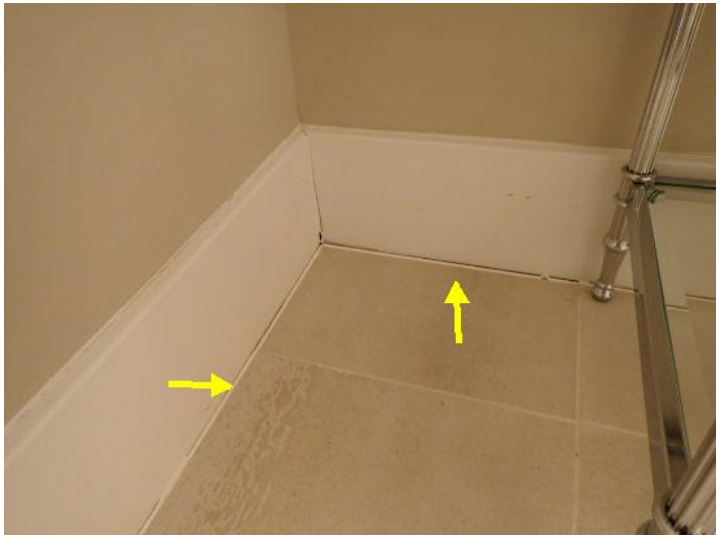
Failed and/or Missing sealant Basement on suit bath

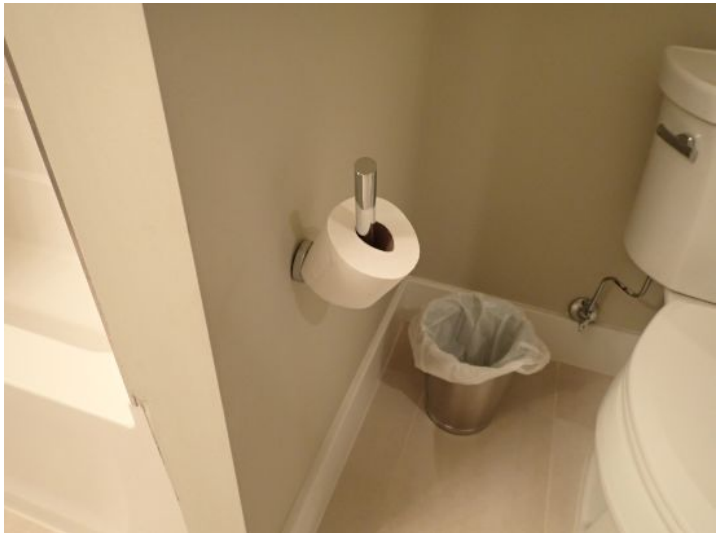
Loose hardware

- Toilet paper holder missing or loose at wall. Recommend securing flush to wall to prevent damage.

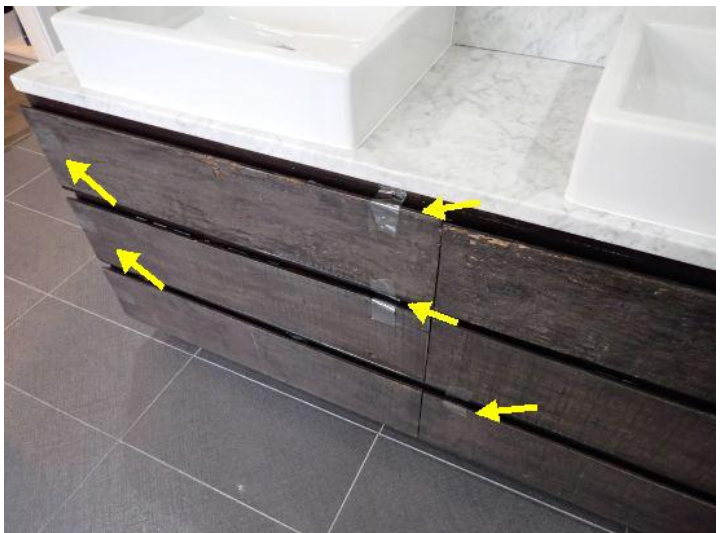
Unable to evaluate

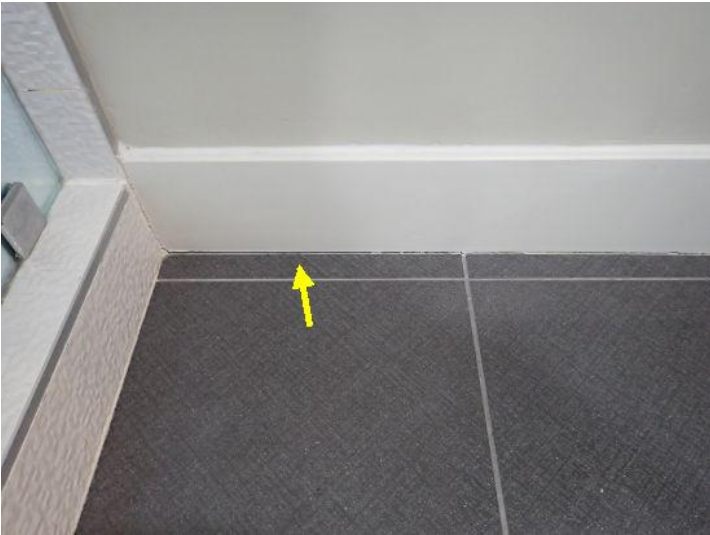
Failed and/or Missing sealant Primary bath

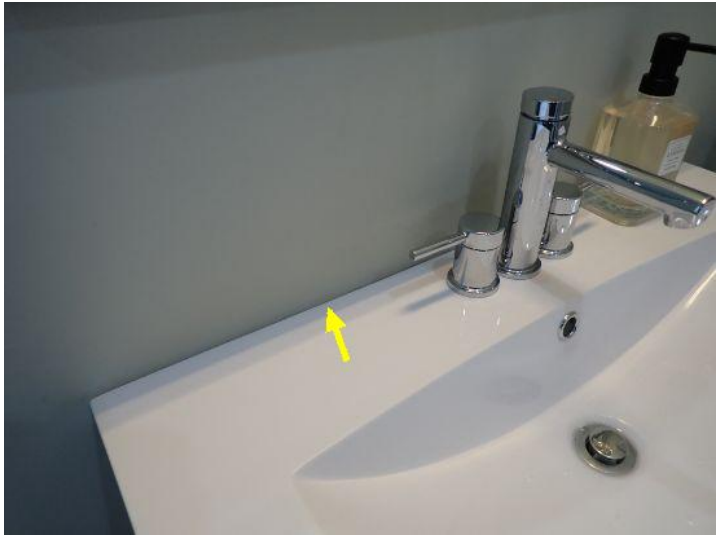
Failed and/or Missing sealant Primary bath

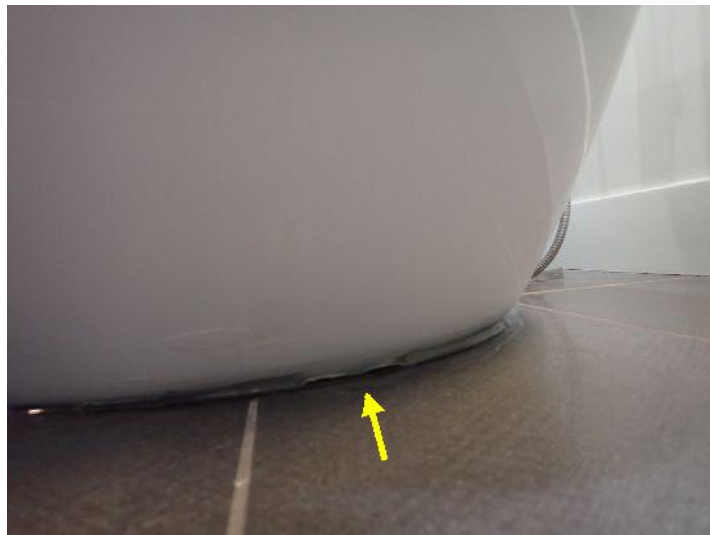
Failed and/or Missing sealant Primary bath

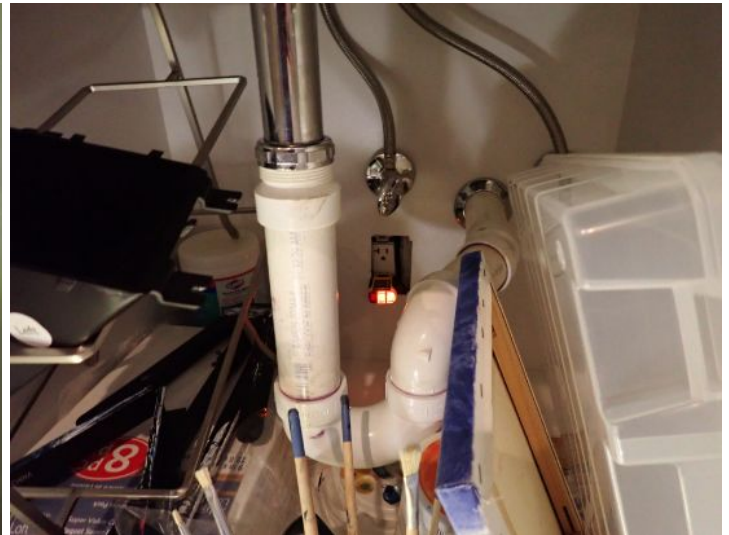
Failed or missing GFCI Basement bar

- Damaged and/or missing outlet cover or switch cover. Replace. This is a safety hazard due to the risk of fire and shock due to access of internal wiring. Cover plates should be installed or replaced where missing.
- **GFCI** test failed. Receptacles are required in kitchens, bathrooms, garages, crawl spaces, basements, laundry rooms and areas where a water source is within 6 feet. Recommend correction to prevent injury.

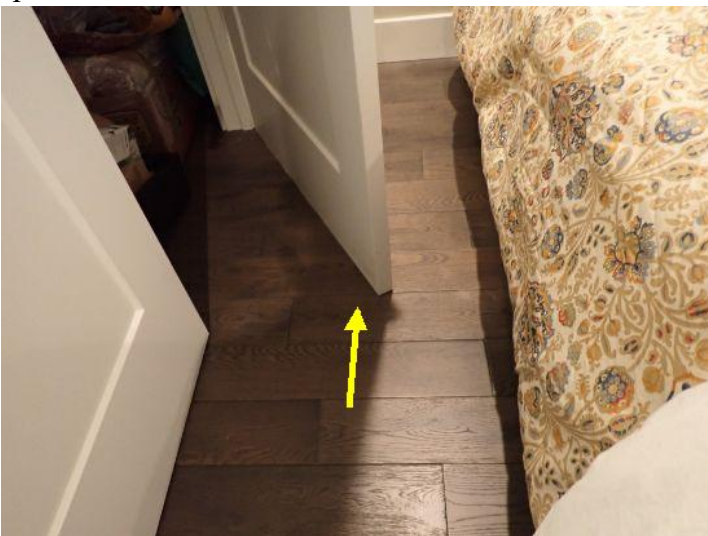
Door rubs Basement bedroom

- Door tight and/or rubs. The door is tight or rubbing, which may affect its proper operation and lead to potential damage. Adjusting the hinges or trimming the door is recommended to ensure smooth functionality and prevent wear over time.

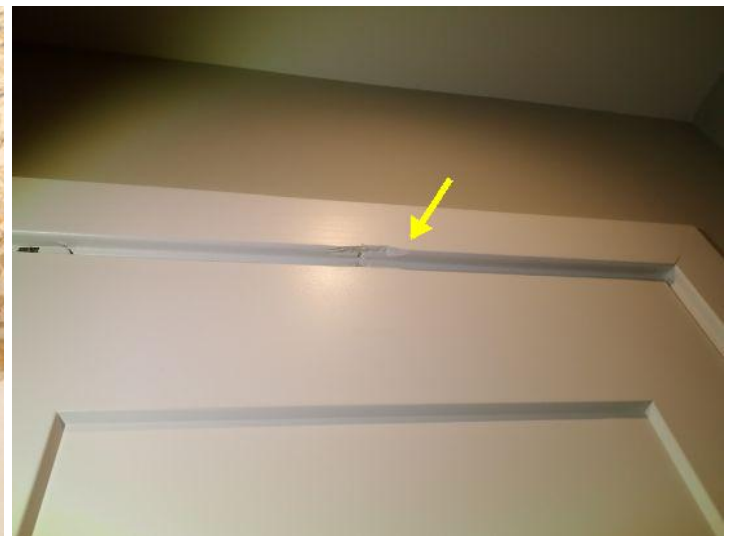
Damaged trim. Basement bedroom

- Damaged and/or missing trim: One or more areas of trim were observed to be damaged or missing. Repair or reinstall affected sections as needed to restore a more finished appearance.

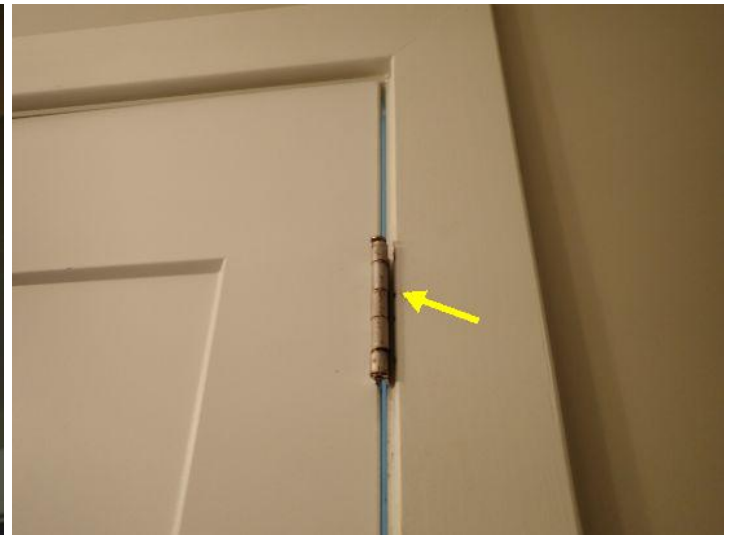
Rusted hardware J&J bath

- Rust visible on hardware. Recommend replacing all damaged or rusted components to prevent damage or injury.

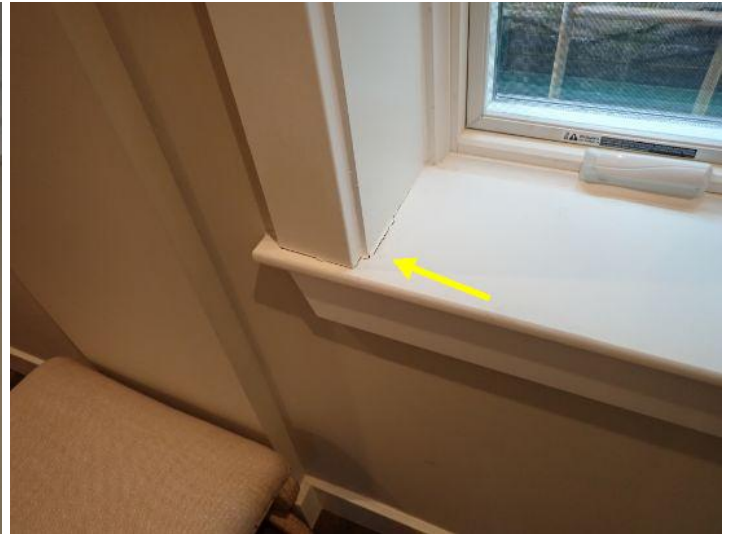
Failed and/or Missing sealant

- Caulk failed and/or missing. Repair. Caulk around windows where missing or inadequate.

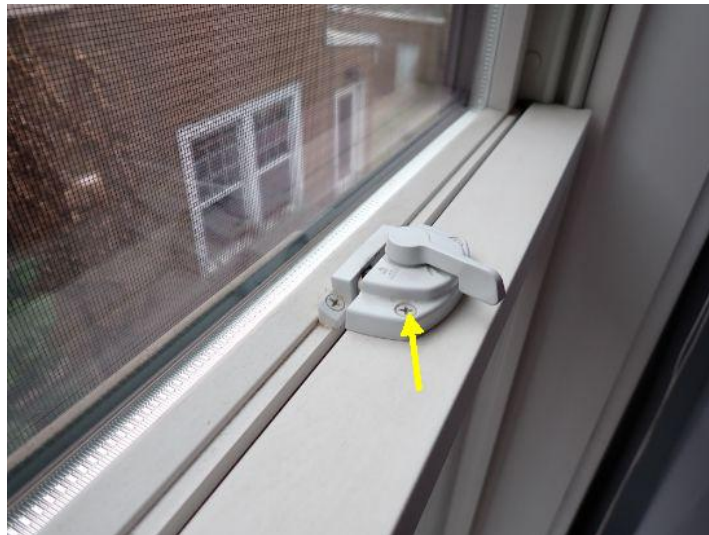
Improper function

- Improper function: Window will not lock under normal operating pressure. Recommend re-aligning, repairing or replace all damaged and/or non-functioning components to ensure proper function.

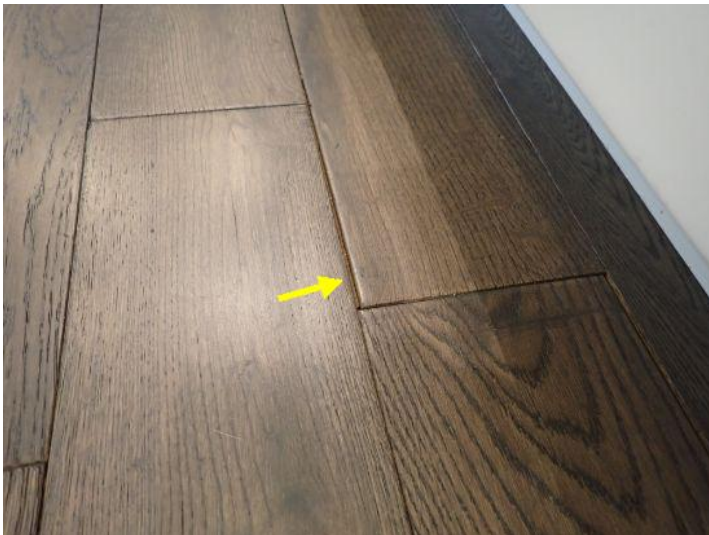
Gap in flooring

- Gap in flooring: One or more gaps were observed in the flooring. It is recommended to repair or replace any damaged or improperly installed sections to help prevent moisture intrusion and potential subfloor damage.
- Missing sealant: Open voids or unsealed joints were observed in one or more locations, where sealant is absent or has deteriorated. These areas present a pathway for moisture intrusion, which can lead to structural damage, interior staining, or organic growth over time. Apply an appropriate interior-grade sealant to fill all affected gaps. Proper sealing helps protect structural materials, maintain a clean appearance, and reduce the risk of moisture-related issues indoors.

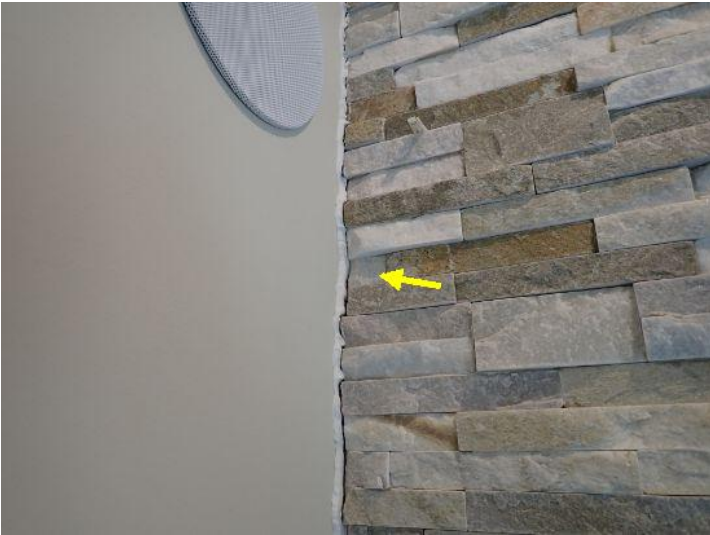
Failed and/or missing sealant Fireplace wall junction

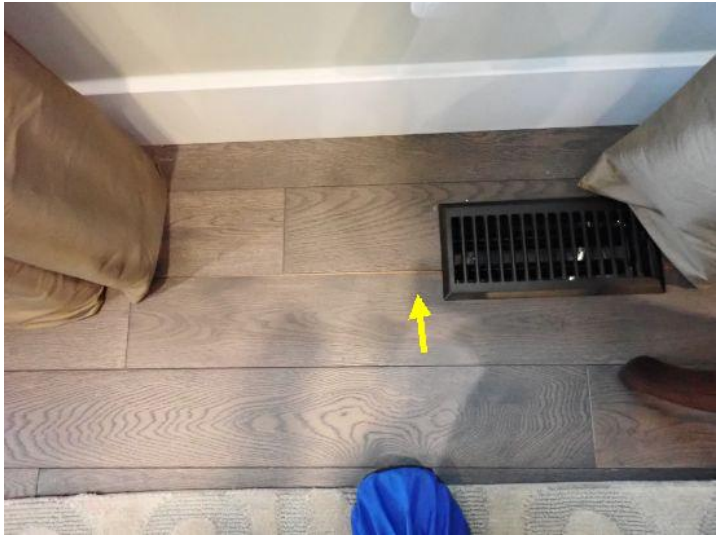
Gap in flooring

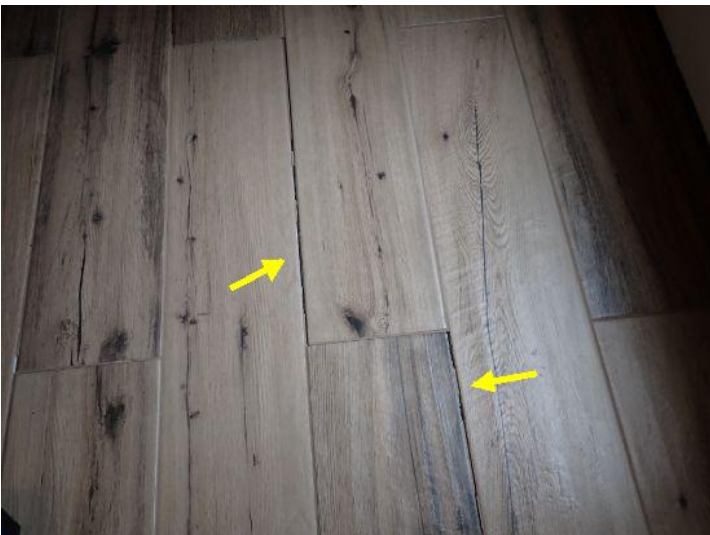
Failed and/or missing sealant Basement walkout

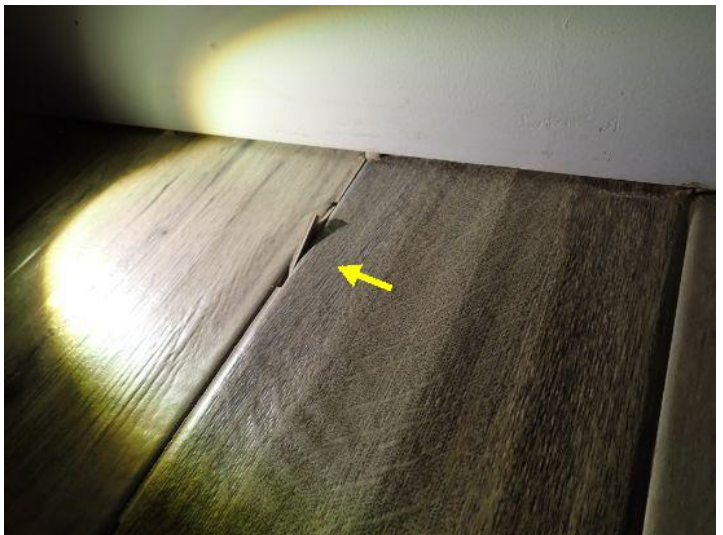
Failed and/or missing sealant Basement walkout

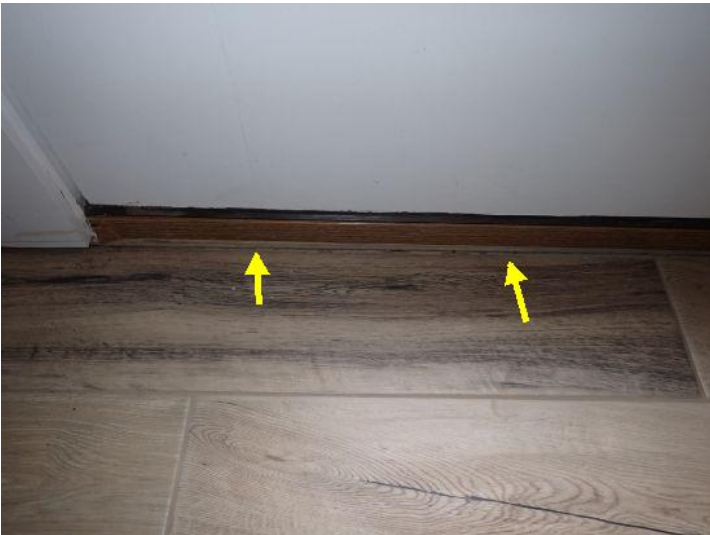
Failed and/or missing sealant
walkout Basement

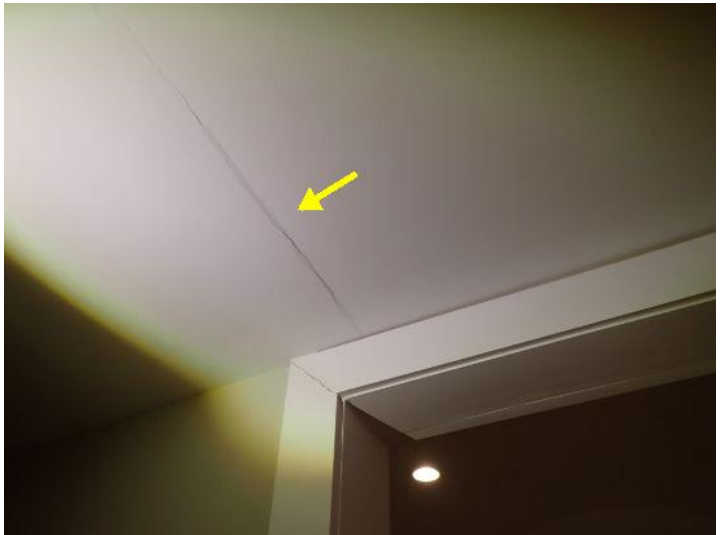
Crack in drywall Basement

- Minor settlement cracks and nail pops as is normal for a house of this age. Monitor.
