Walker Home Inspections

Your Property Inspection Report

Date of Inspection: 1/5/2026 Time: 10:30 - 1:30 pm
Age of Home: 2016 Size: 5800 sq ft

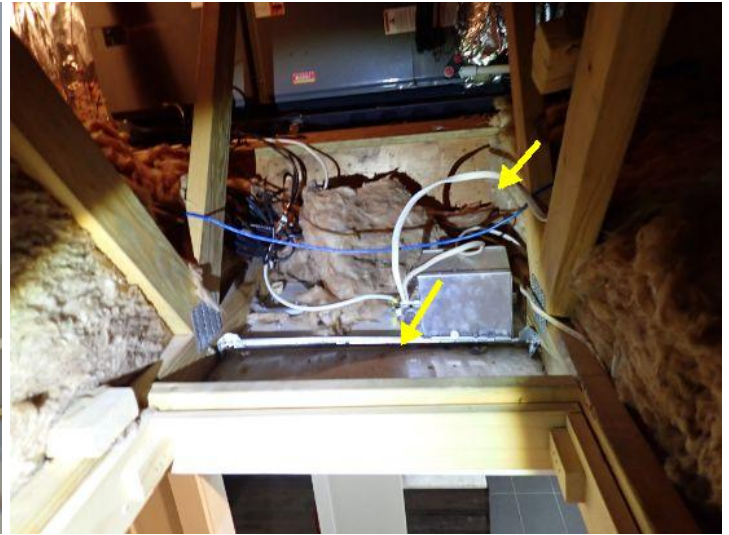
Low or Missing insulation

- Inadequate or Missing Attic Insulation: Attic insulation was observed to be missing, displaced, or insufficient in one or more areas, which may contribute to increased energy loss, reduced indoor comfort, and higher utility costs. Proper insulation is essential for maintaining consistent indoor temperatures and reducing the load on heating and cooling systems. Install insulation to achieve at least an R-49 thermal resistance value throughout the attic, in line with modern building standards. This can be accomplished with approximately 16"–20" of loose-fill fiberglass, 13"–15" of tightly installed fiberglass batts, or 14"–17" of loose cellulose or mineral wool batts. Apply insulation evenly, avoiding gaps, low spots, or compression to ensure optimal performance and thermal efficiency.

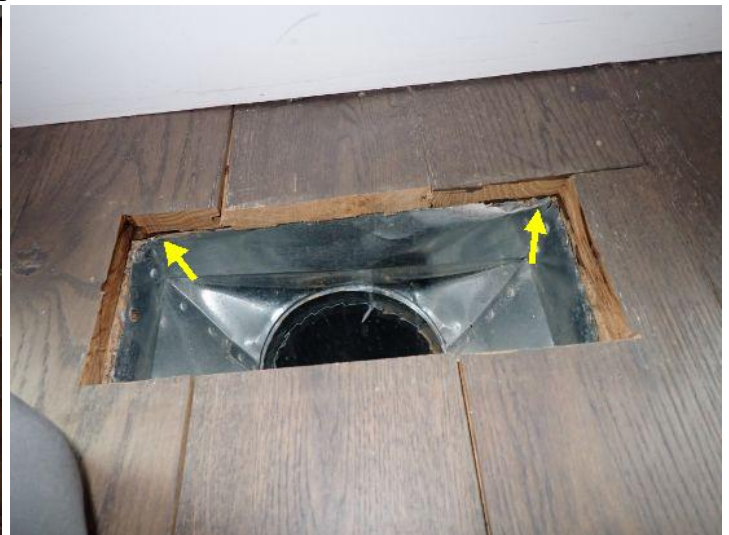
Missing sealant

- Sealant is missing around the floor register boxes, which may lead to drafts, pest entry, or energy inefficiency. It is recommended to secure and seal the perimeter of all floor register boxes to address these issues effectively and maintain a well-insulated and protected home environment.

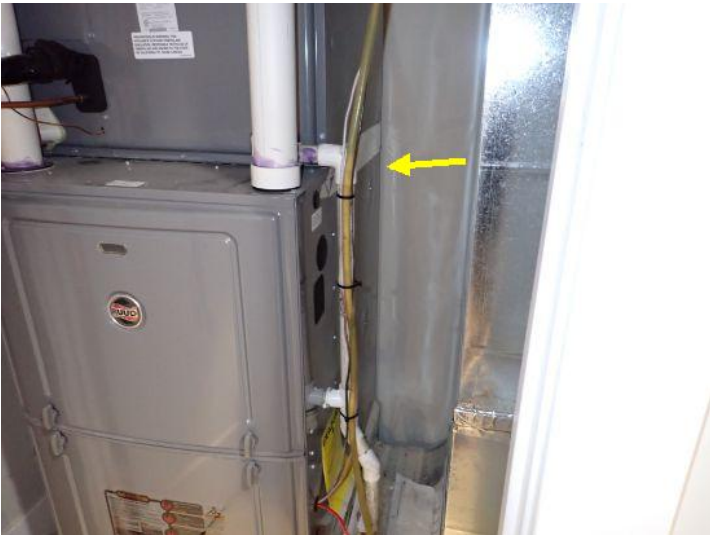
Missing "P" trap

- Trap(s) missing or inaccessible. Condensate drain line. Repair. Prevent energy loss. A trap in the line prevents conditioned air from being pushed out of the drain. Install a P trap with an accessible cleanout. Traps need periodic cleaning. You can prevent a clogged AC drain by performing routine cleaning. By pouring a ¼ cup of vinegar into your AC's drain line, you will kill any mold, algae, mildew, and other forms of bacteria or fungi, preventing it from forming a buildup and causing a clog. Repeat this monthly for the best results.

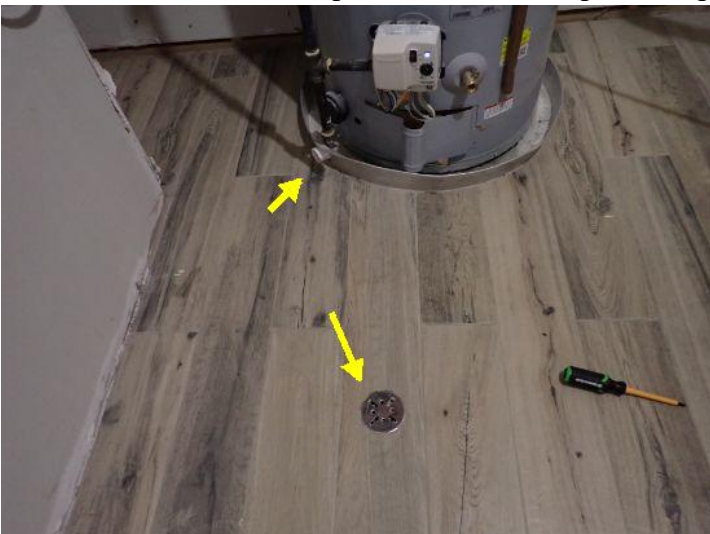
Missing drain line

- Missing drain line. The water heater is missing a drain line extension. It is recommended to install an extension that directs discharge to the floor drain to help prevent potential water damage.

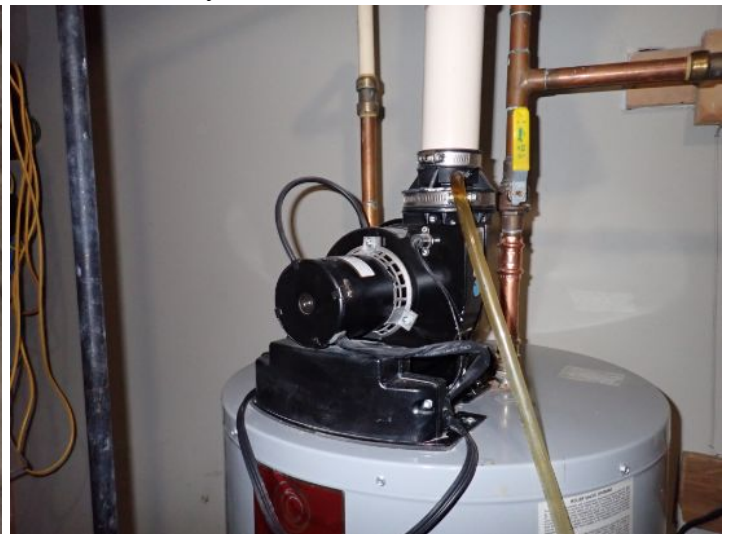
Loud motor

- Loud exhaust motor: Exhaust motor operating louder than normal, possibly due to a worn bearing or hardware issue. Monitor performance and repair or replace as necessary.

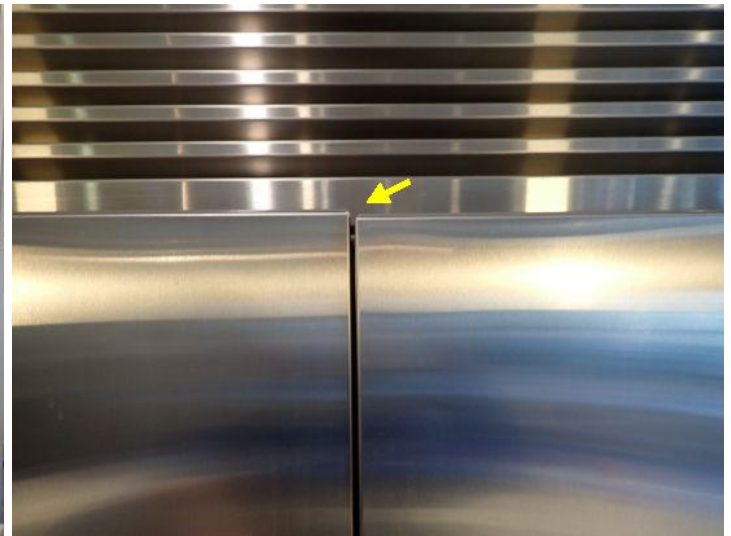
Misaligned door

- Handle loose. Recommend securing refrigerator handle to prevent damage.
- Door misaligned: Refrigerator door is out of alignment. Recommend adjusting it to ensure a tight seal and a cleaner, more finished look.

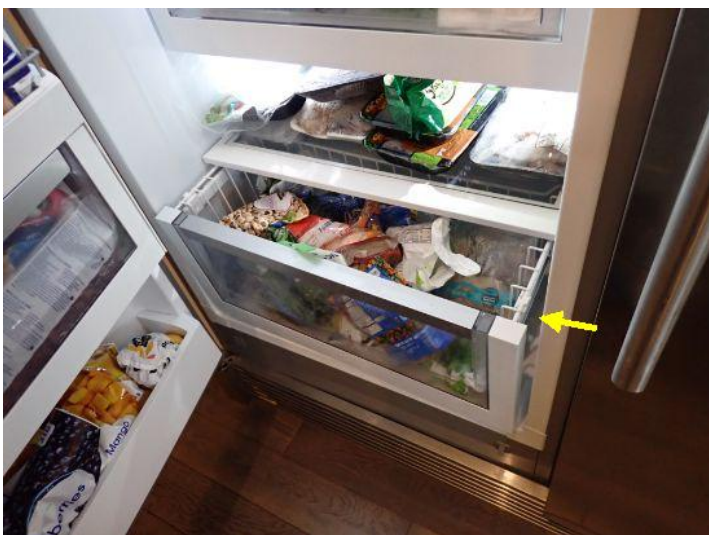
Improper function

- Improper function: Freezer drawer will not stay closed, indicating improper function. Recommend further evaluation to determine the cause and repair or replace as needed.
