Walker Home Inspection

Property Inspection Report

Your Home , Hometown, VA
Inspection prepared for: Sample Report
Date of Inspection: 9/6/2022 Time: 9:45-12:30 pm Size: 5000 sqft
Weather: Recent rain

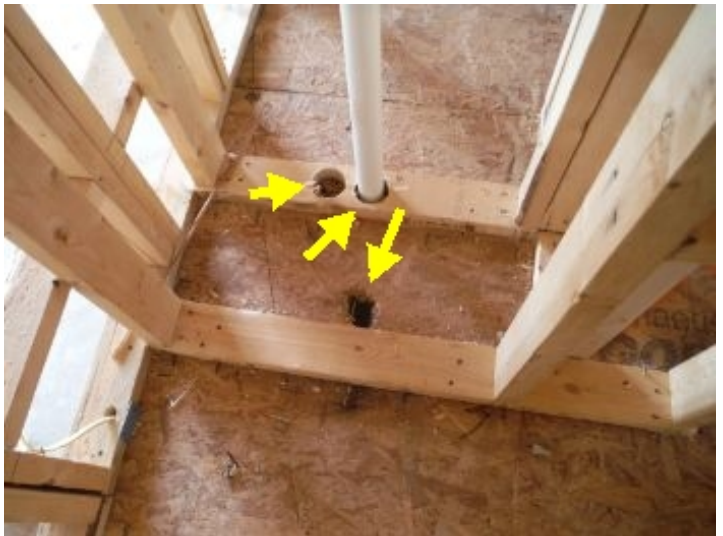
Fireblock not visible/ hole in floor sheathing

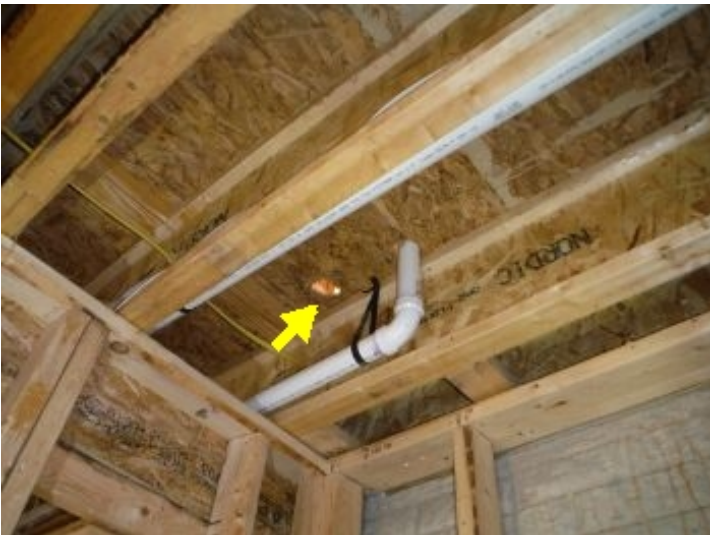
Hole in sheathing

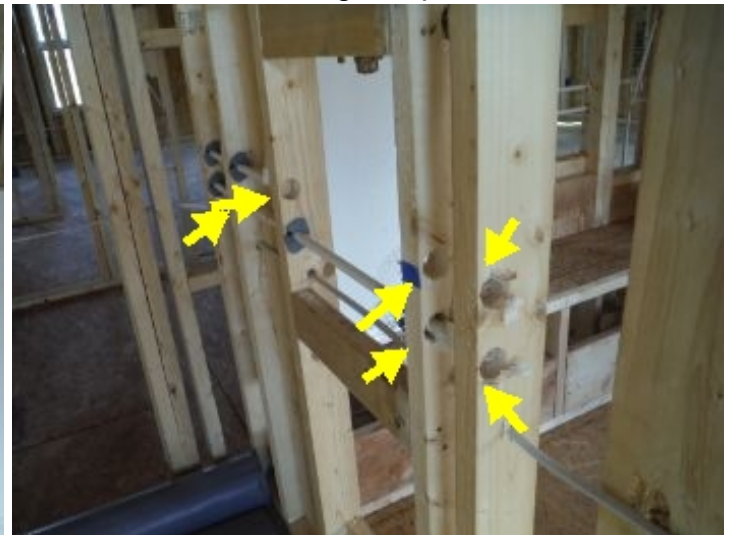
Hole to close to edge

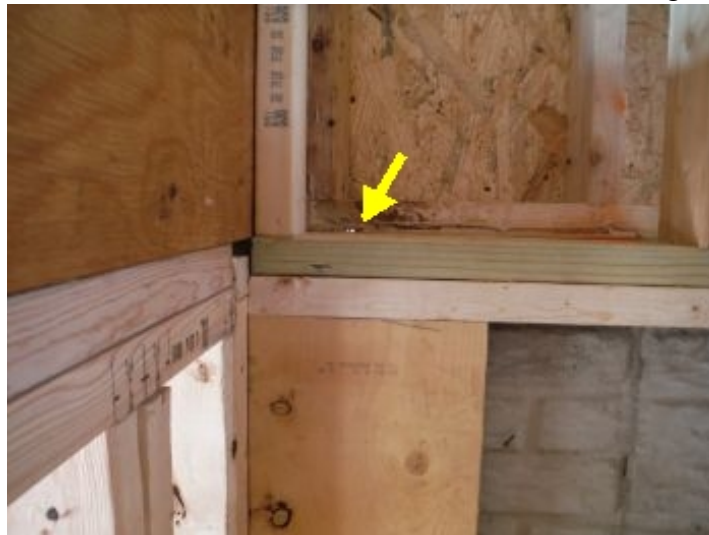
Missing sealant Stairs

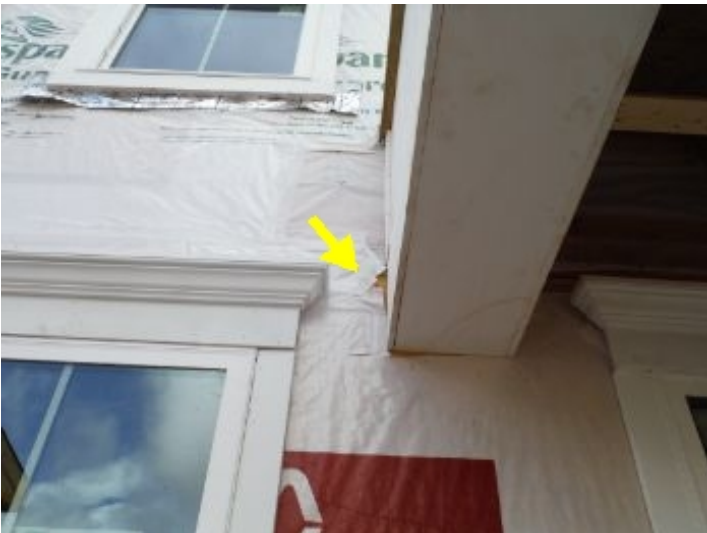
Loose, damaged and/or missing house wrap

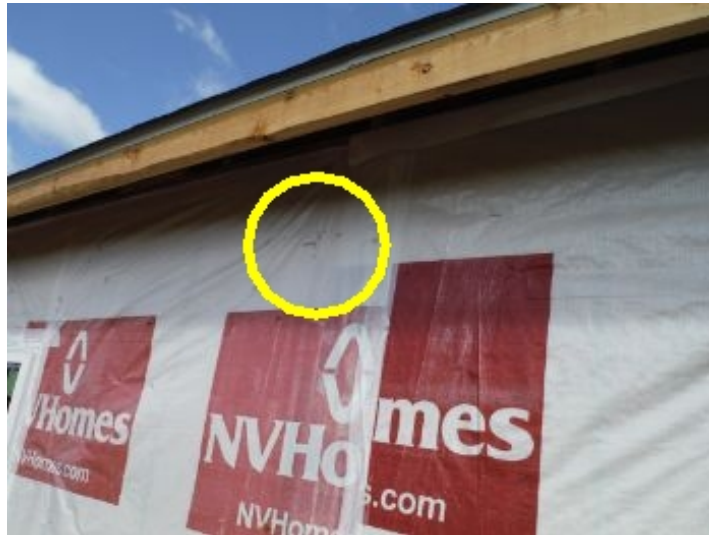
Loose, damaged and/or missing house wrap

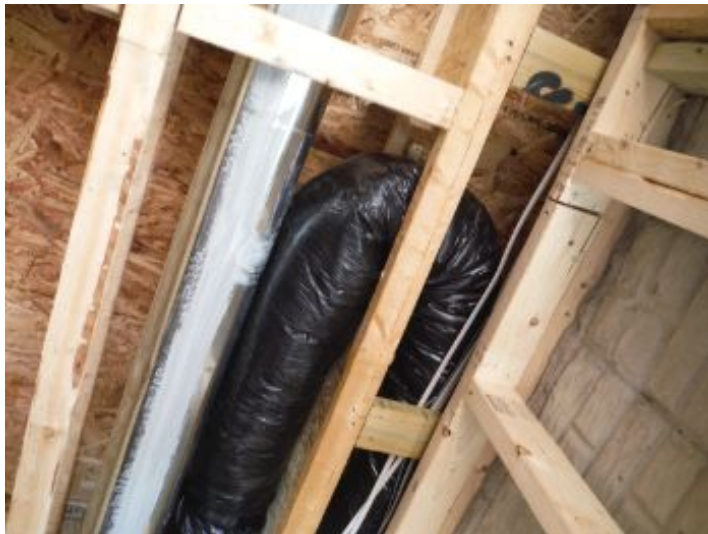
- Excessive duct bend: Repair. Excessive bent duct will restrict airflow by create drag. The radius of the bend should be no less than the diameter of the duct, per the manufactures instruction.

Excessive duct bend
