Walker Home Inspection

Property Inspection Report

Your Home , Hometown, VA
Inspection prepared for: Sample Report
Date of Inspection: 9/6/2022 Time: 9:45-12:30 pm Size: 5000 sqft
Weather: Recent rain

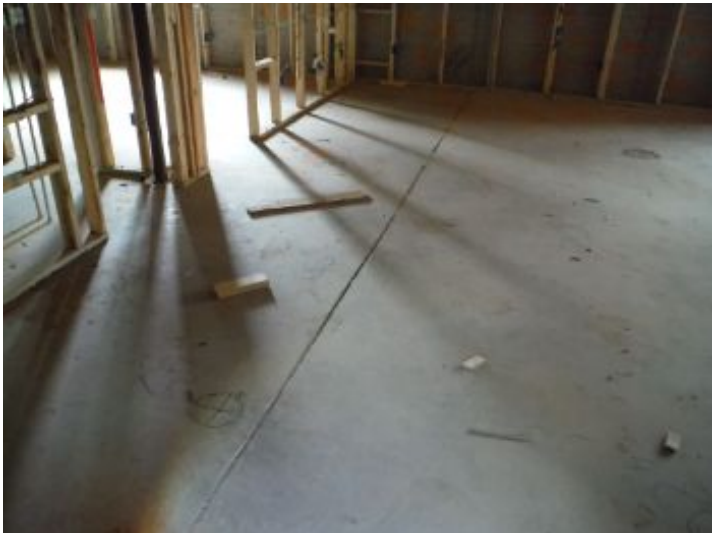
- Crack visible. Repair and monitor. Cracks 1/4" or less are generally not regarded as being structurally significant. Recommend patching area and sealing to prevent possible entry points for moisture, radon gases and to prevent further damage.

Recommend sealant

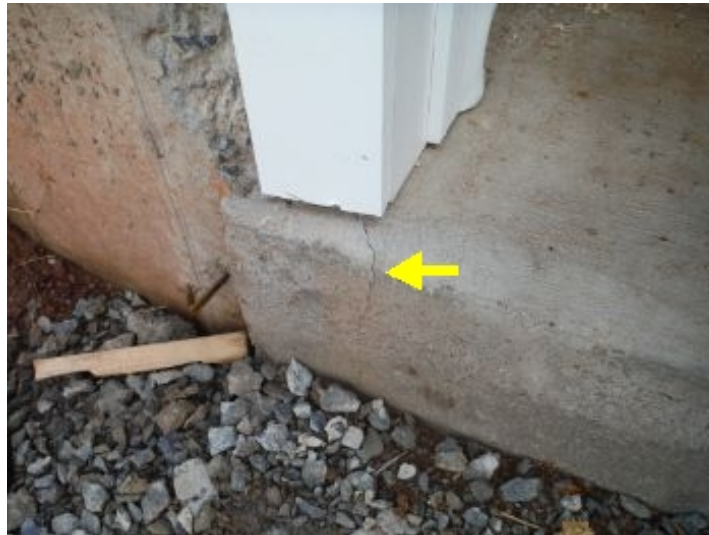
Crack visible

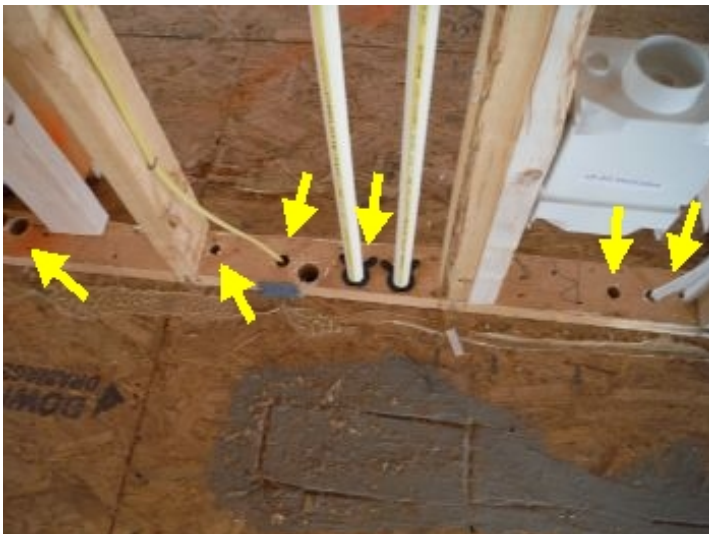
Fireblock not visible

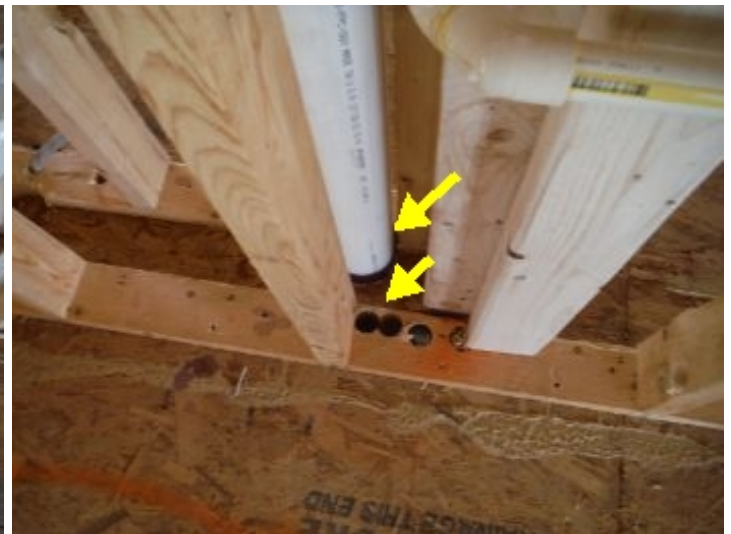
Fireblock not visible

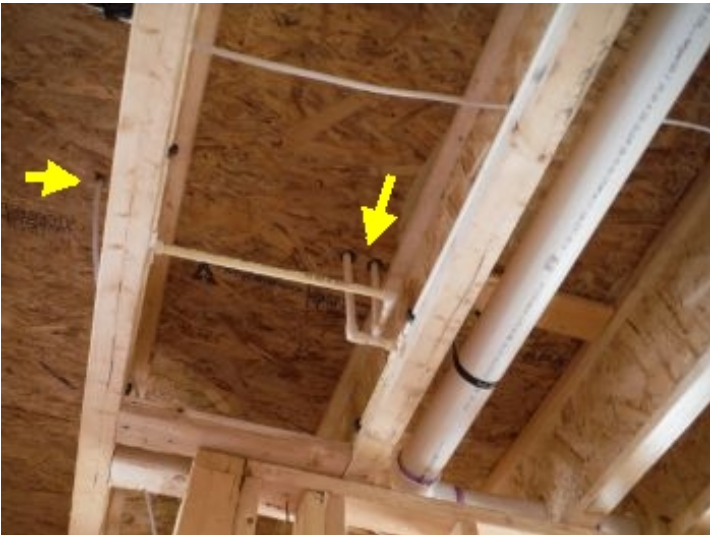
Fireblock not visible

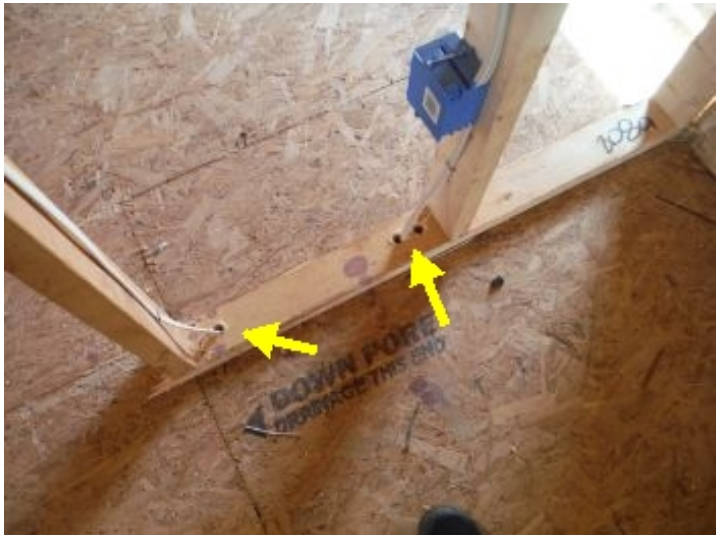
Fireblock not visible

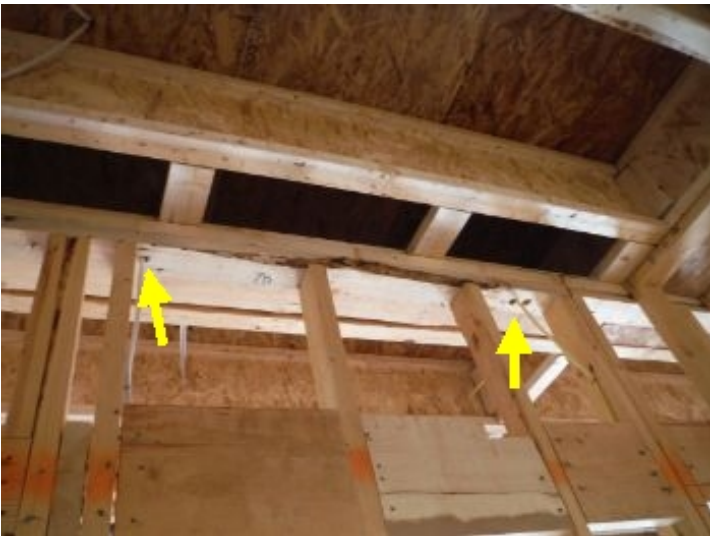
Fireblock not visible

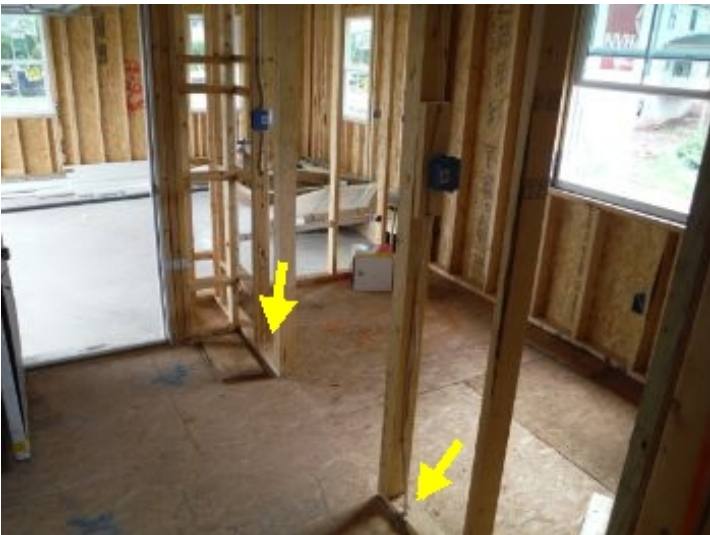
Fireblock not visible

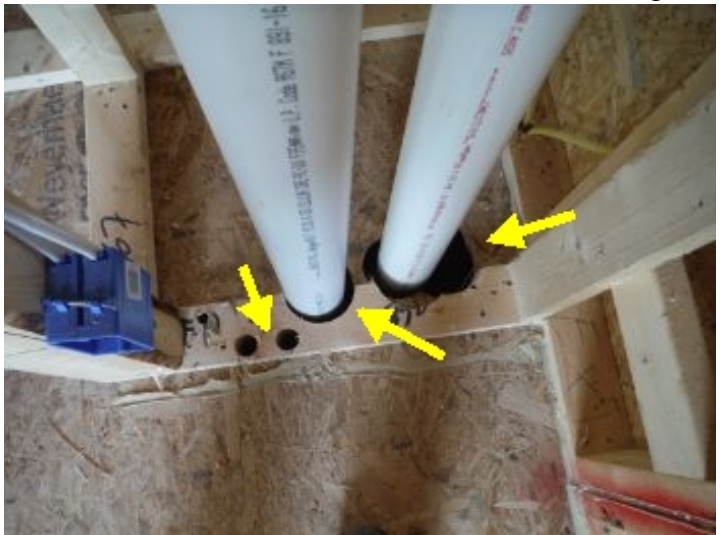
Fireblock not visible

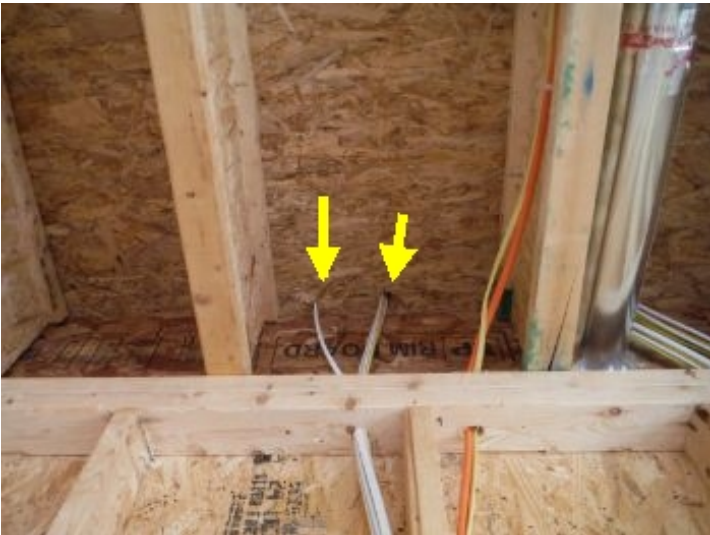
Fireblock not visible

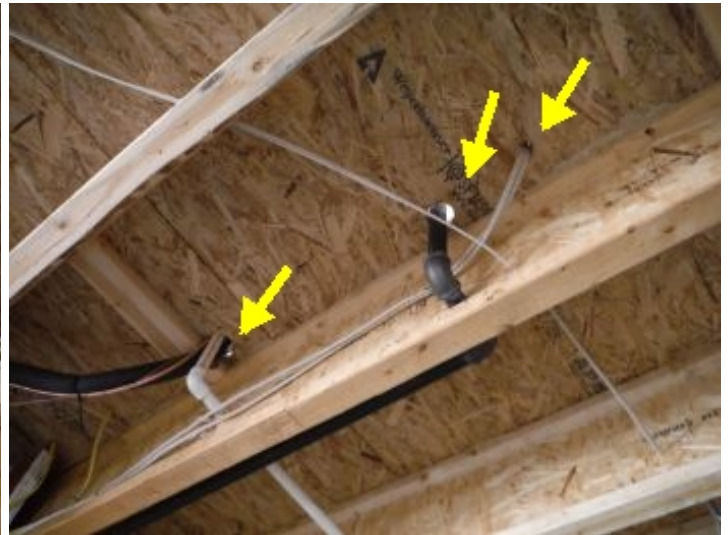
Fireblock not visible

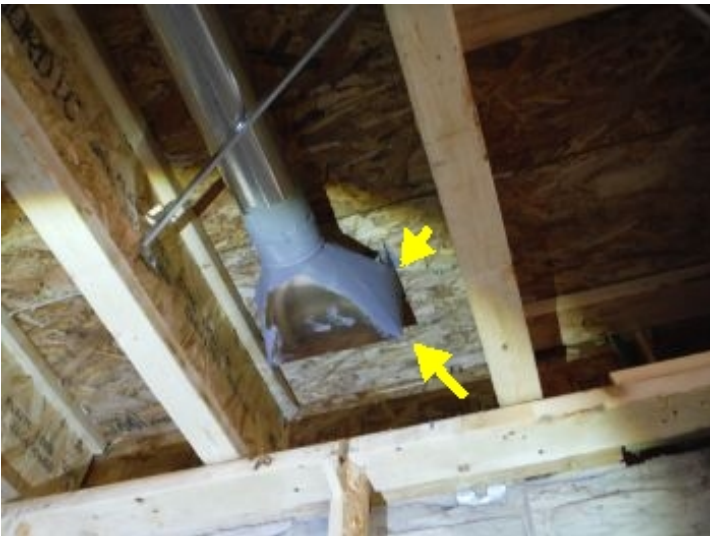
Fireblock not visible

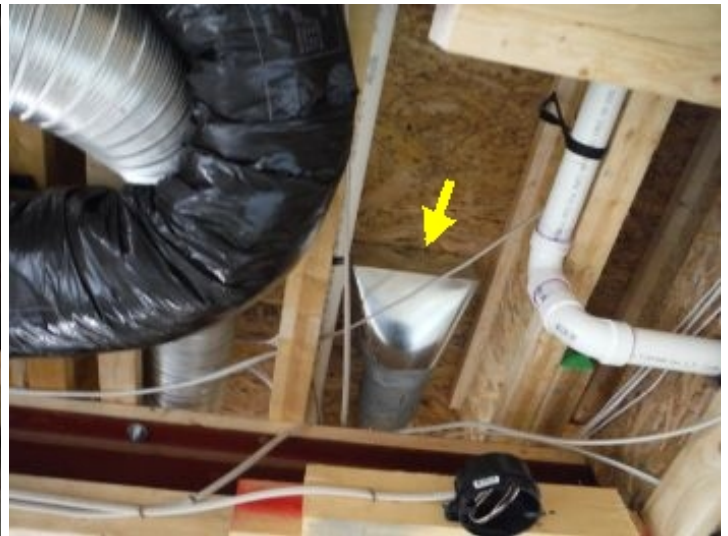
Fireblock not visible

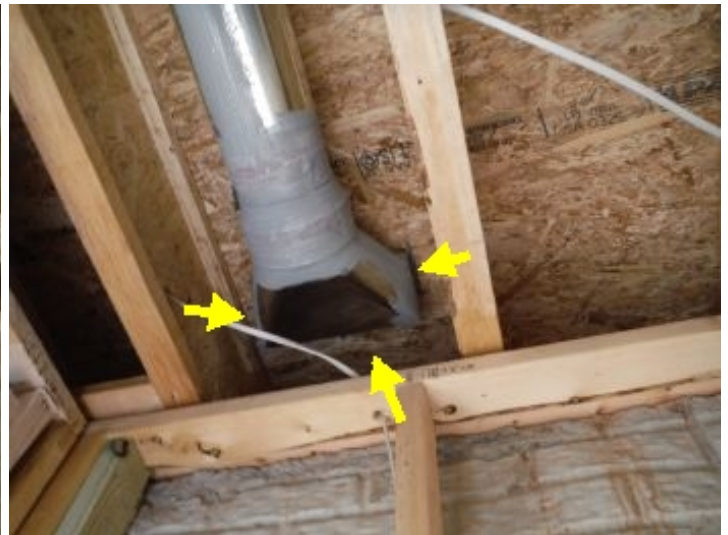
Fireblock not visible

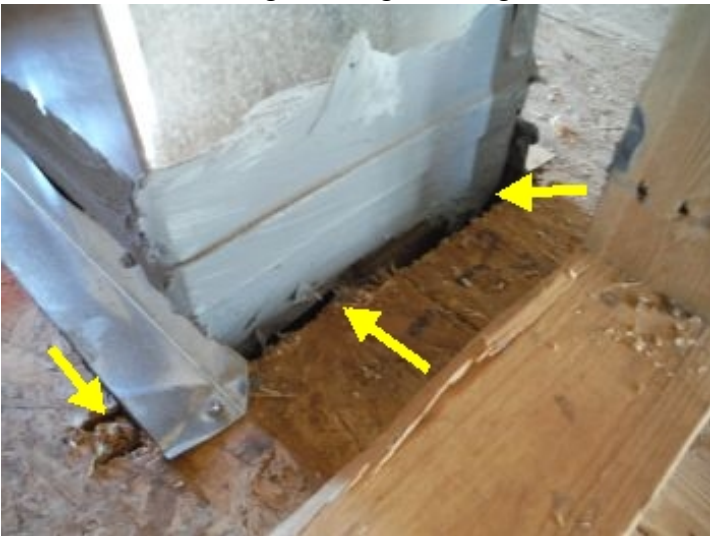
Fireblock not visible

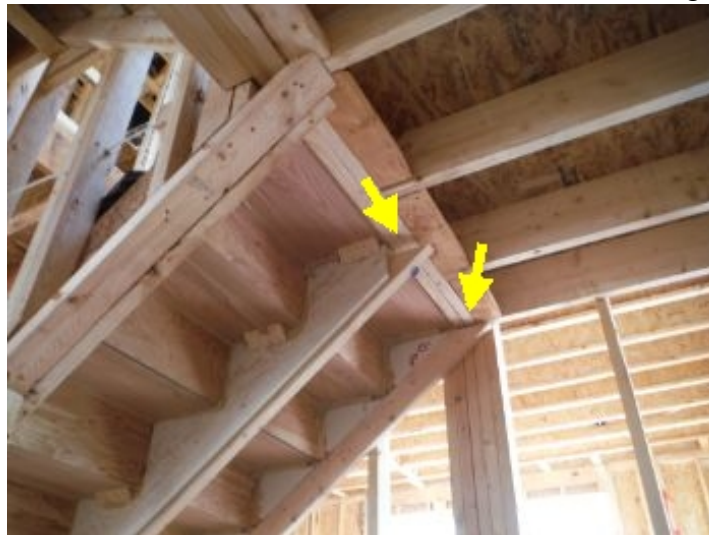
Weak connection

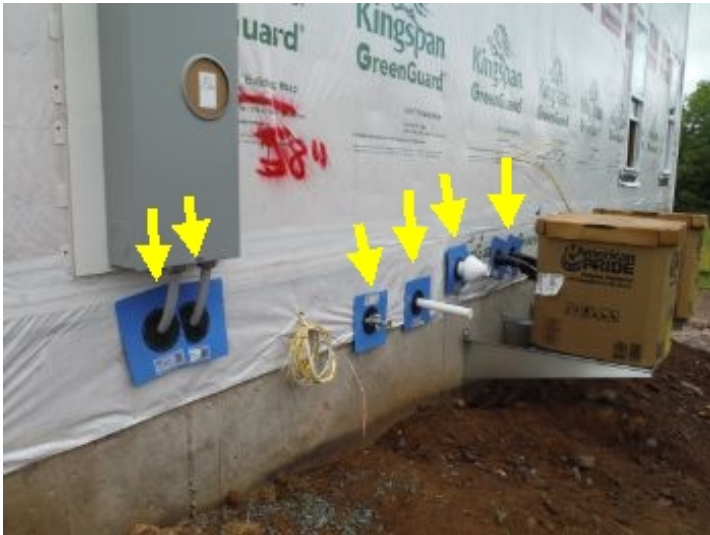
Incomplete installation

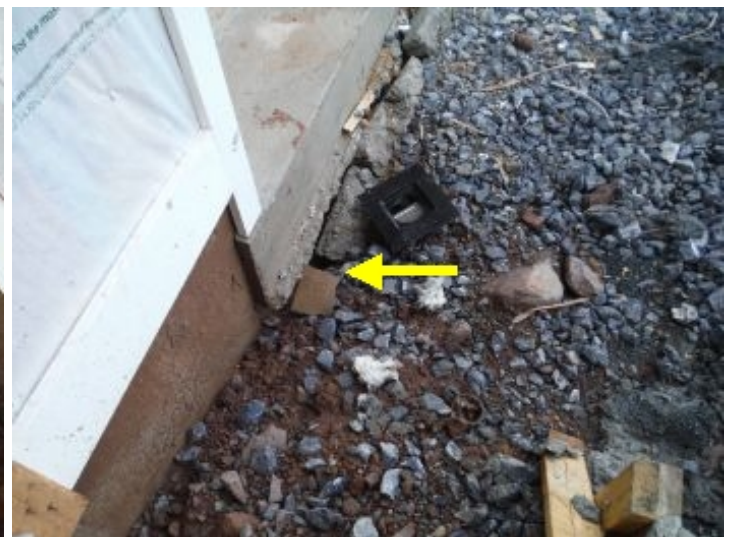
- Low area. Repair. Recommend adding additional back fill to prevent water from pooling and draining to foundation wall.

Low area

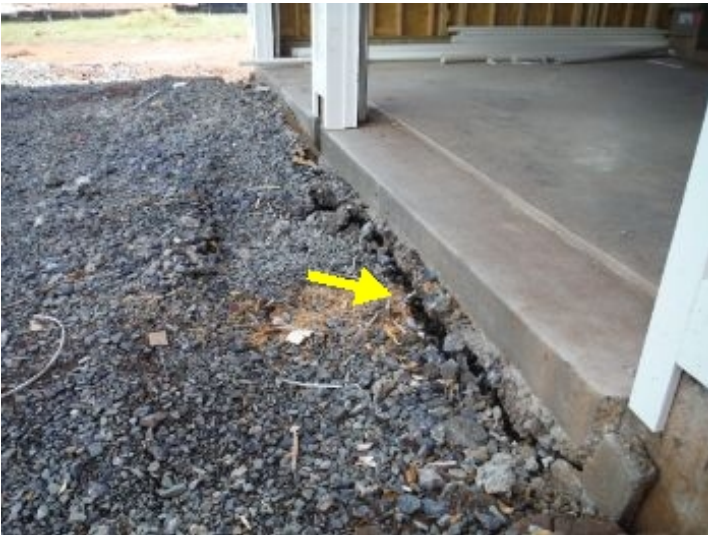
Low area

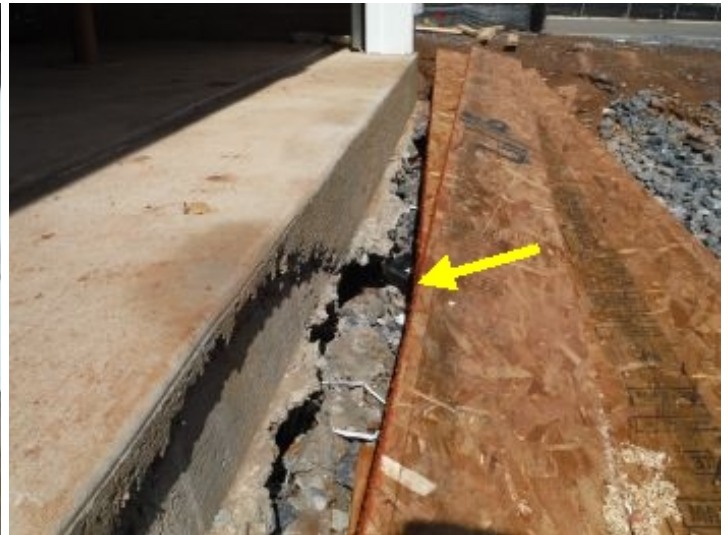
Low area

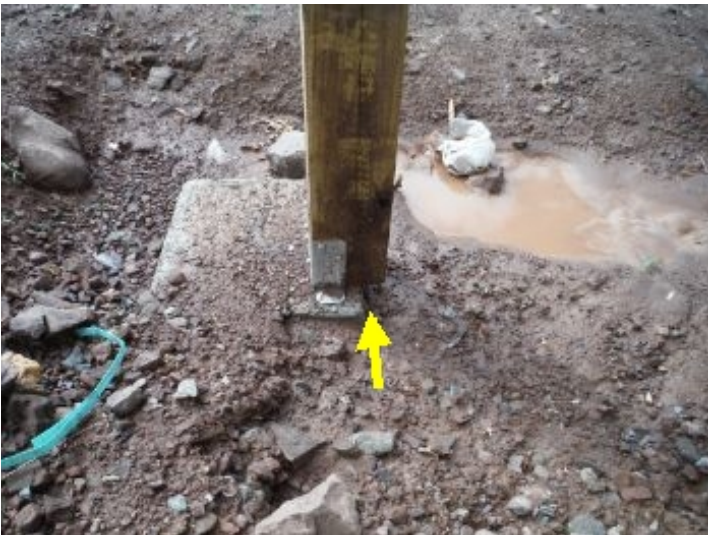
- Improper bearing: Balcony post misaligned. Recommend correction to ensure proper load bearing.

Misaligned post

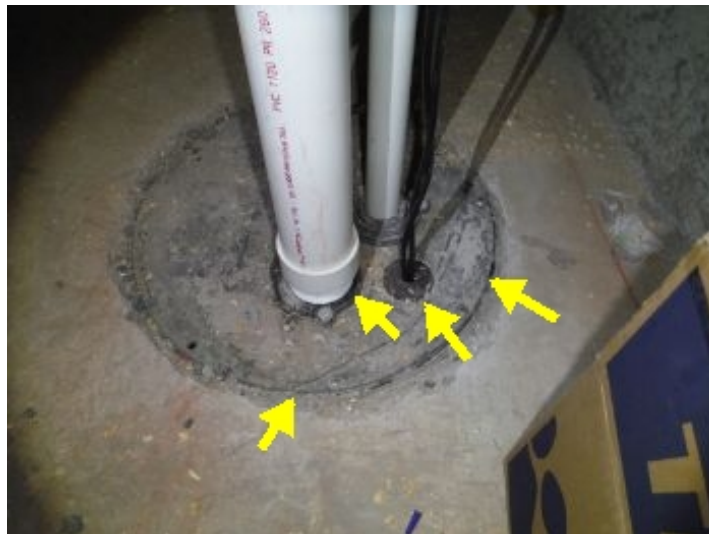
- When radon system is installed with the sump well, it is important to keep an air tight seal to prevent any gas from entering the home.

Recommend sealing

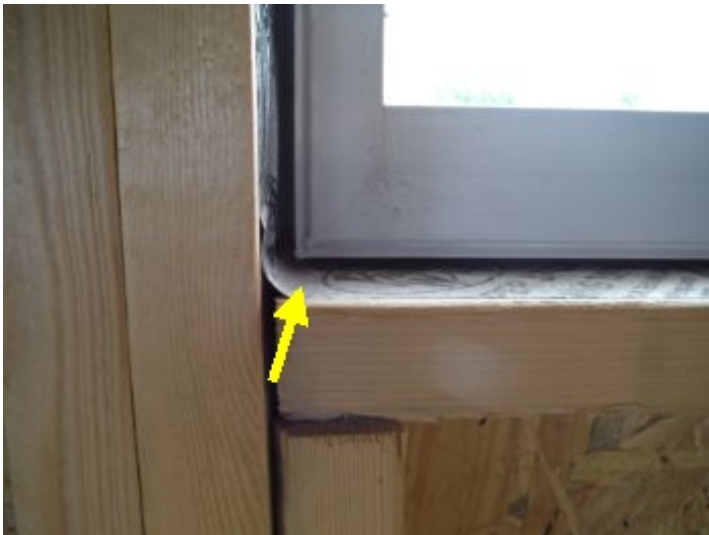
- Window shims missing: Recommend installation: Prevent damage to window(s) install window shims under all vertical window jambs. Have windows properly shimmed before sealant is installed.

Missing shims
